**JT-60SA**

Status Update  
06 September 2022

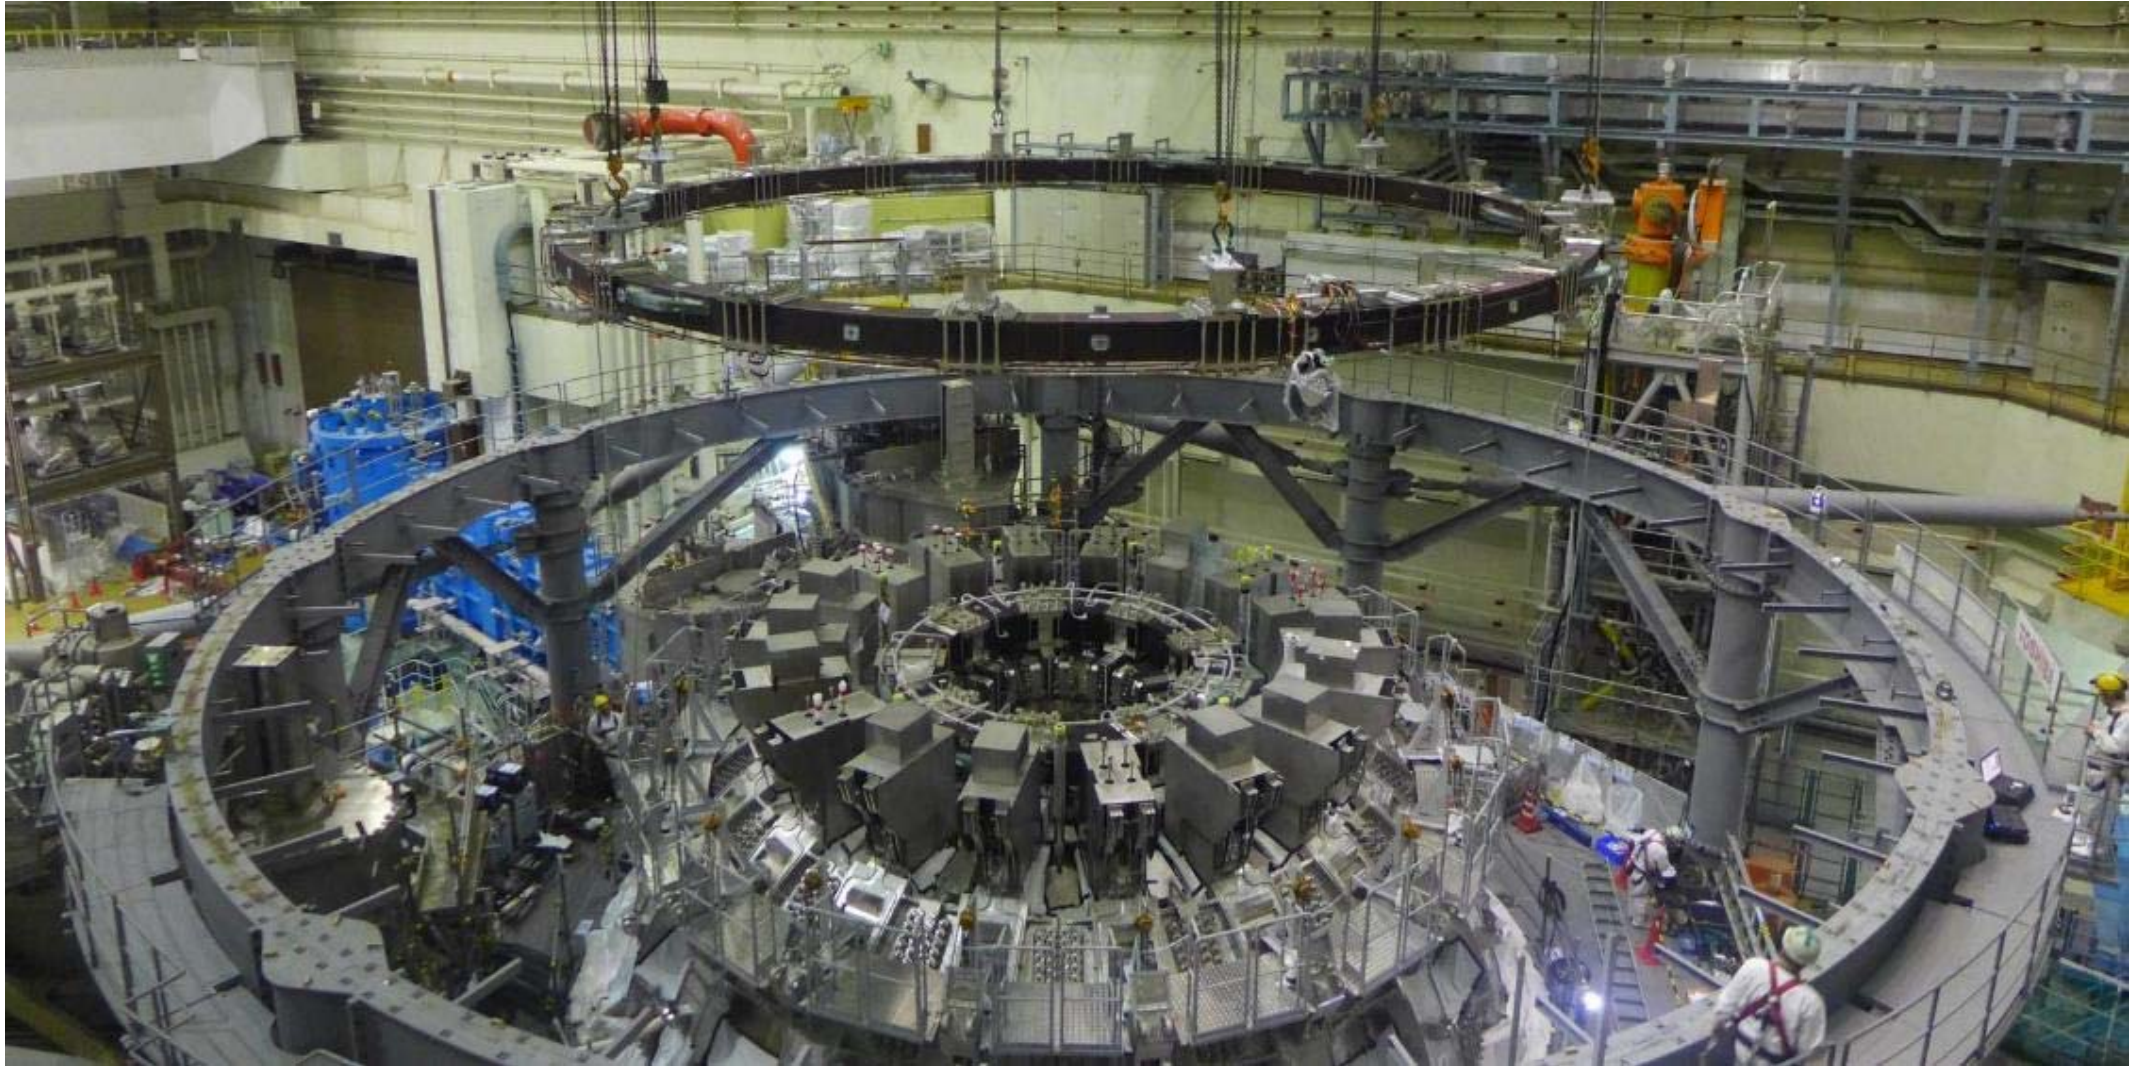
*EF1 installation in 2018*

- Arc occurred between the EF 1 terminals on 09 March 2021 with 350 A in the coil
- Exact failure mechanism is still unknown since no degradation of cryostat vacuum was detected before the arc
- Target: Paschen-proof tokamak

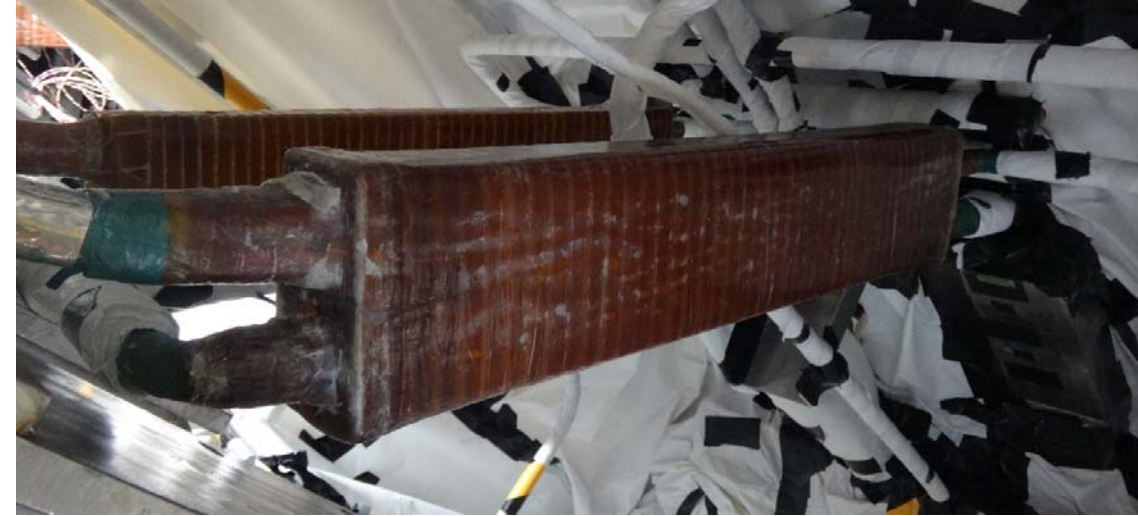
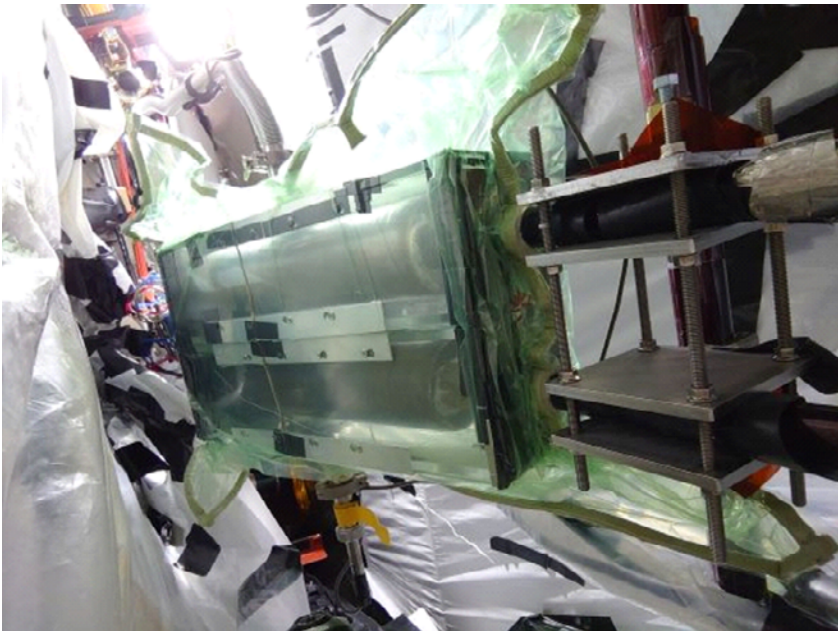
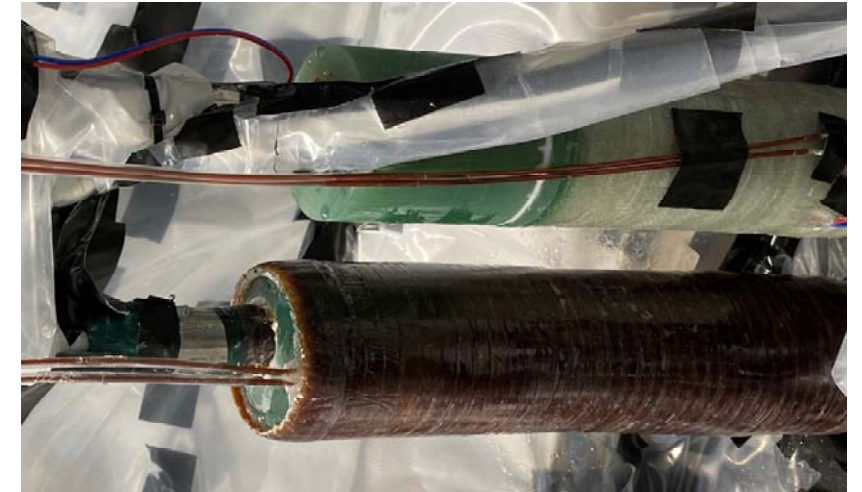
- 84 joints and associated quench detection (QD) cable extractions
  - 36 TF terminal joints
  - 20 EF & CS terminal joints
  - 28 mid-feeder joints

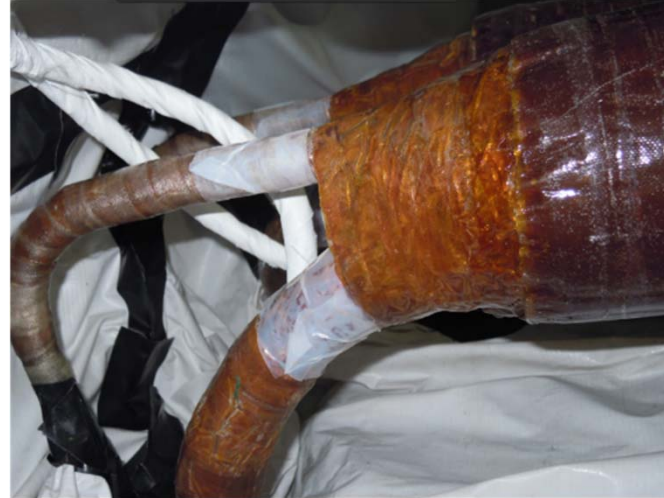
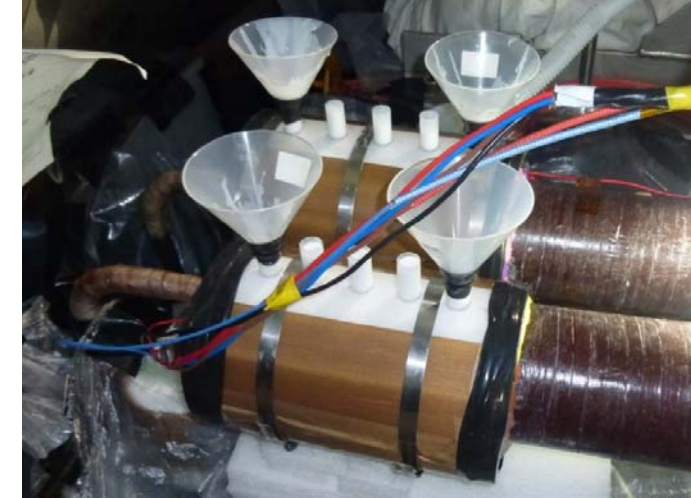
- “Complex geometry” near EF and CS terminals
  - 4-core wire extraction points
  - Conductor and pipe exits
  - ... 30 customized solutions

- 26 current leads (4 locations each)
- Feeder quench detection wires replaced with individually screened cables
- One-off faults on TF 2 feeder and TF 15 tail
- All reinforced positions tested under local Paschen conditions (including numerous QD wire joints and feedthroughs)

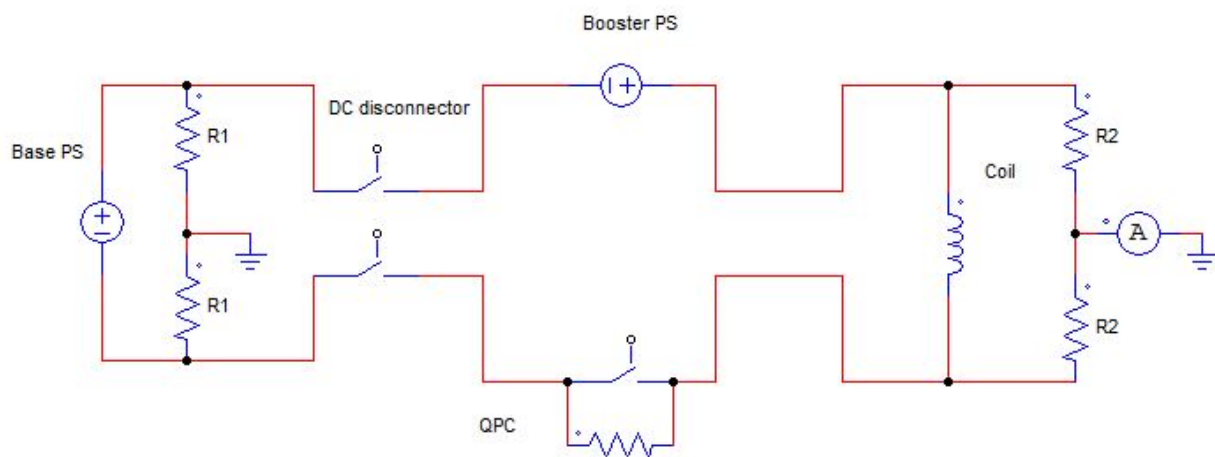
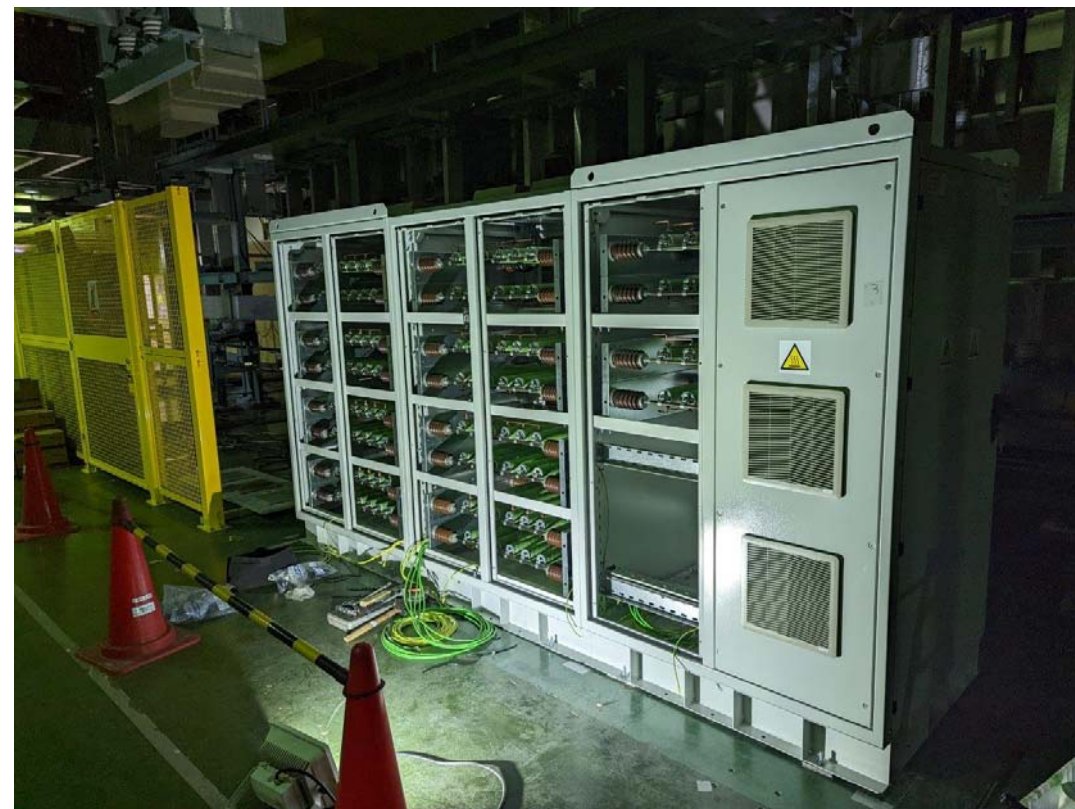
*New "R2" grounding resistors under installation*

- Mid-point grounding has been implemented for the superconducting coils, effectively halving their potential versus ground during operation

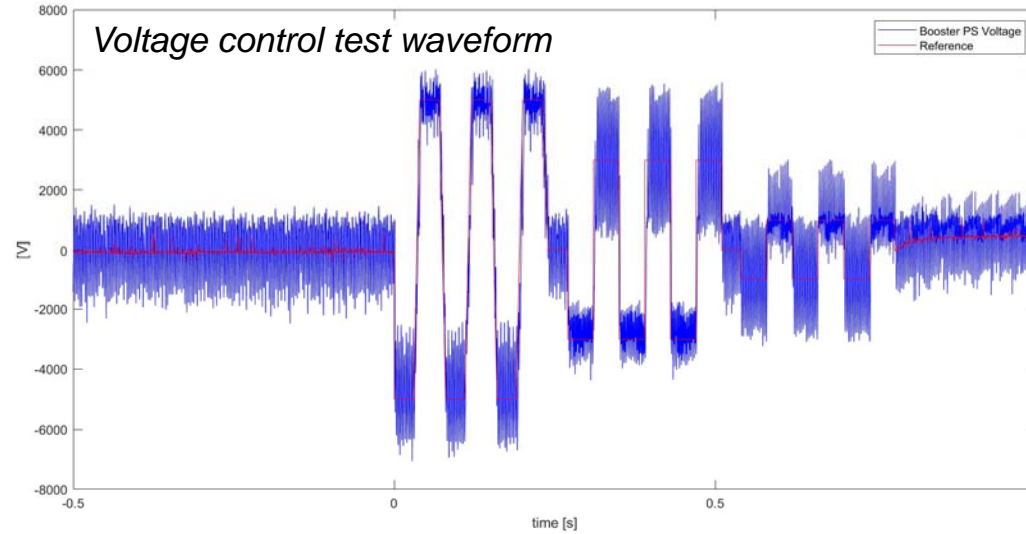
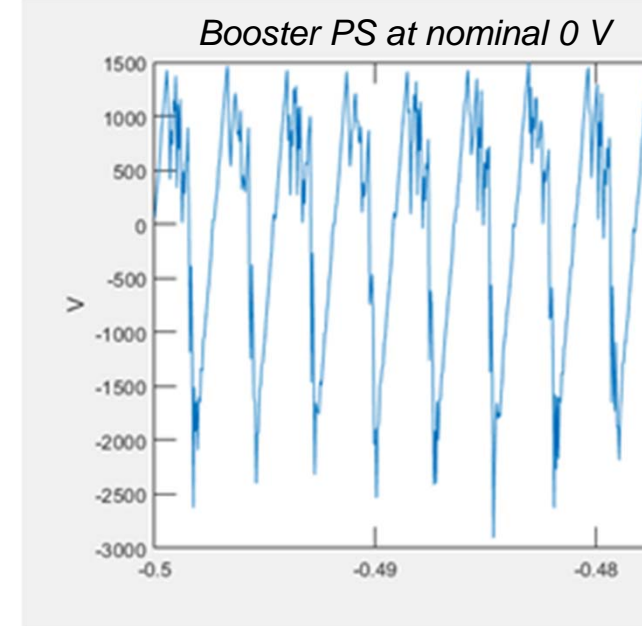
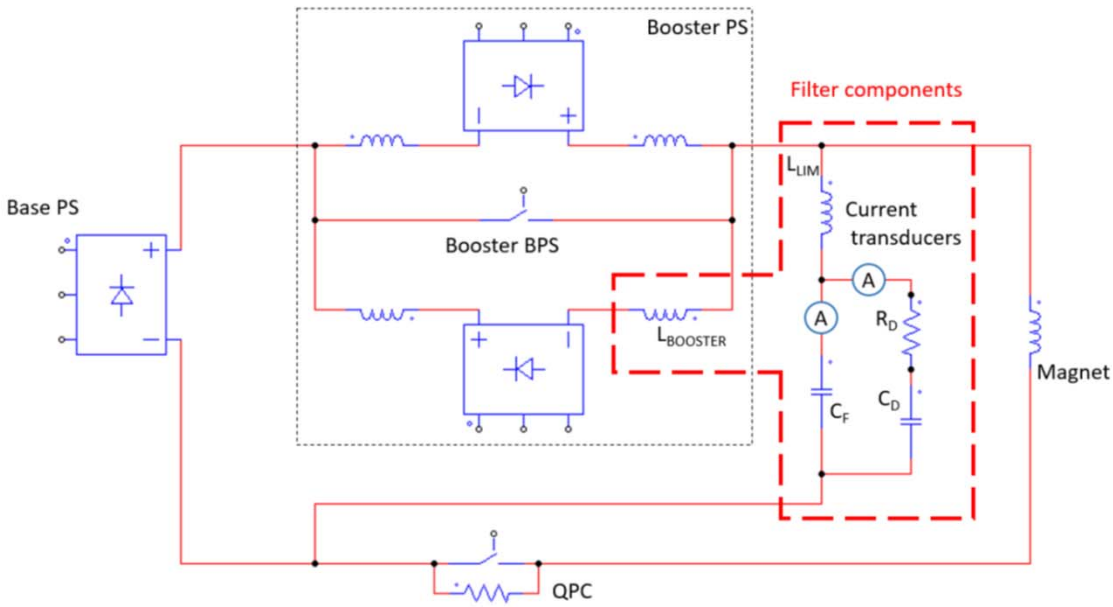
- Booster power supplies used on EF 1,2,5 and 6 are reused from JT-60U.
- Thyristor convertor technology results in very high voltage ripple

- Ripple may have been a contributing factor to EF1 arc; or at least increases applied voltage
- Filters will be fitted to the booster power supplies to reduce the ripple
- Booster power supplies will not be operated until filters are installed

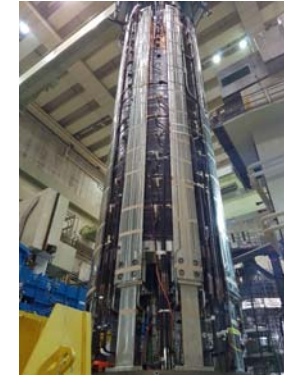
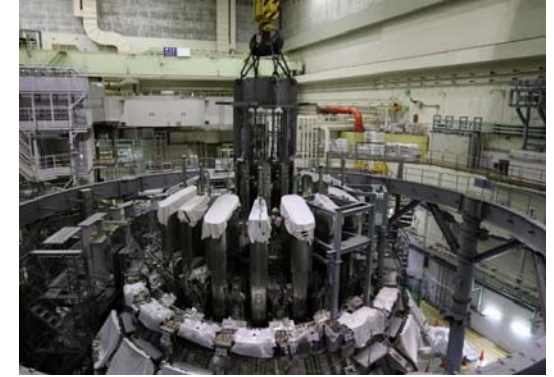
*CS cannot be accessed for conventional repair in situ*

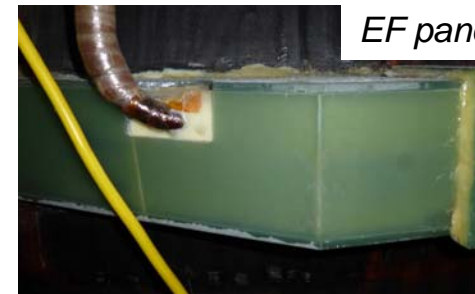
- With the exception of the central solenoid, until June 2022 it was expected that the Global Paschen test would confirm the integrity of the machine (or identify locations needing further work)
- In June 2022, further weaknesses were identified within the EF coils: pancake joints and helium inlets
- Nevertheless it was thought that the Global Paschen test
  - could confirm the integrity of the TF circuits
  - may determine a voltage below which the PF coils could operate safely irrespective of any loss of cryostat vacuum
- The voltage required for operation is driven by plasma breakdown
- Before the Global Paschen test, all PF were tested at 15 kV and all TF at 3 kV in atmospheric air (i.e.  $1e5$  Pa)

*EF pancake joints*

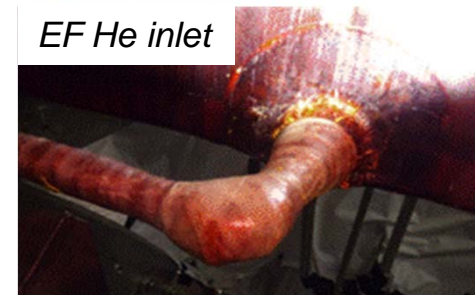
*EF He inlet*
