# Microscopy measurements of tokamak/stellarator and reference samples. Surface analysis capabilities.

**Elżbieta Fortuna-Zaleśna**  
**Warsaw University of Technology**

# W7X samples - tile HM19TM400hTE2

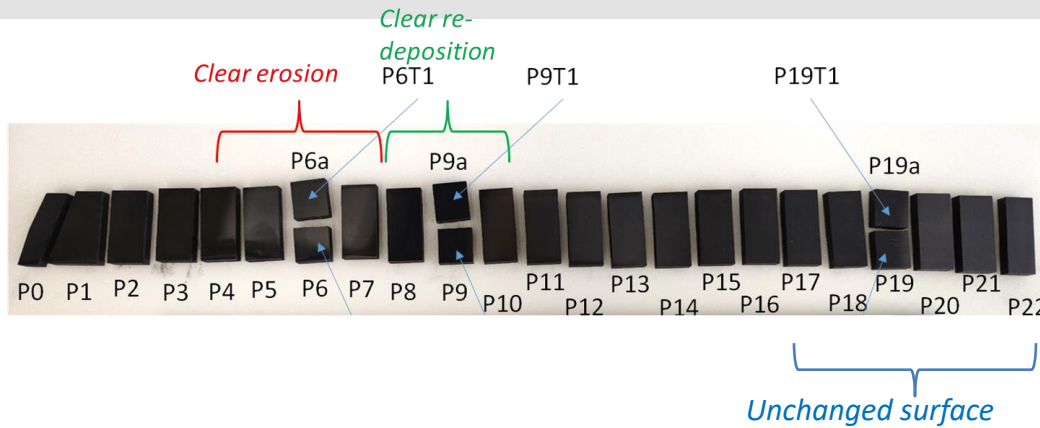
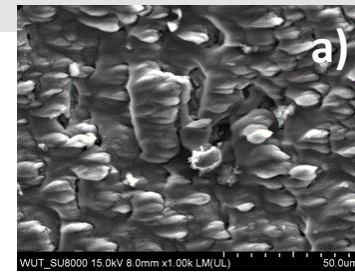
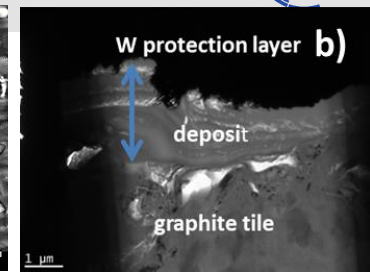
a) SEM image of the morphology of the re-deposited zone, b) TEM image of re-deposited layer, sample 9a.

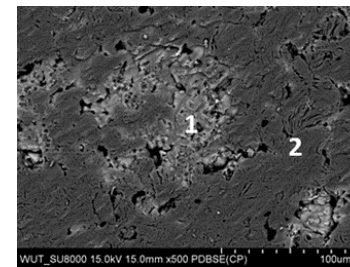
SEM image of clear erosion zone morphology, sample 7. Traces of deposit in the shallow cavities (shadowed areas designated as 1). Strongly smoothed surface (area 2).

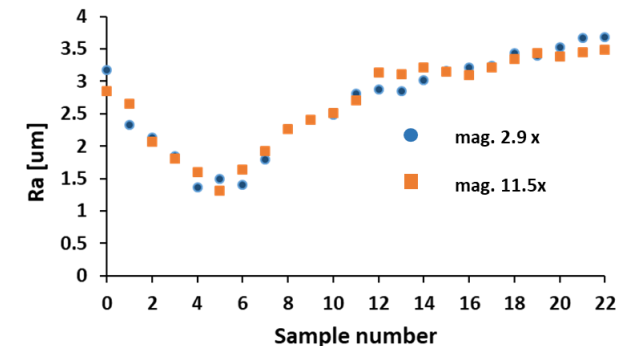
Changes in surface roughness along the length of the tile.

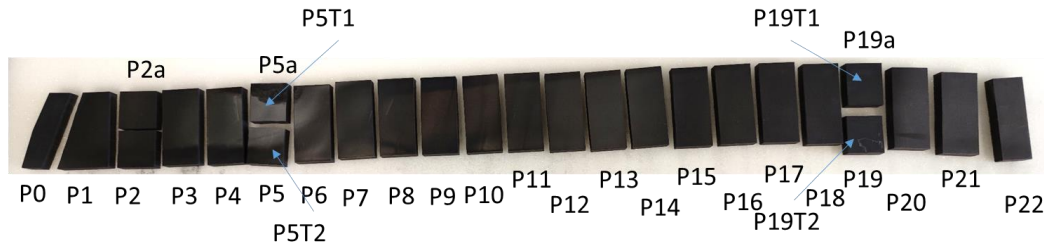
**Note:** damaged zone in samples designated as 4, 5 and 6 (result of an overloading experiment)

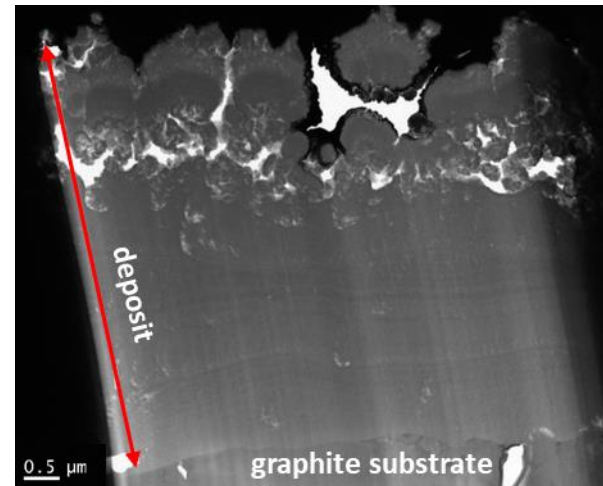
TEM image of deposit present in the damaged zone of sample 5. A thick layer of re-deposited material was revealed.

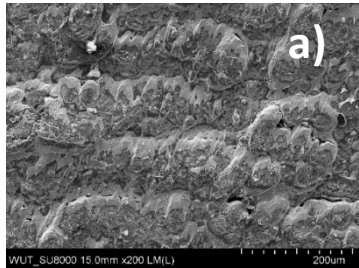
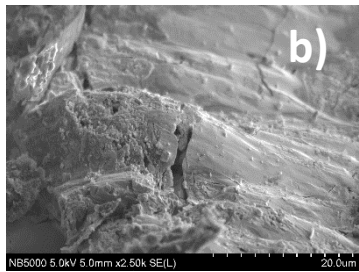
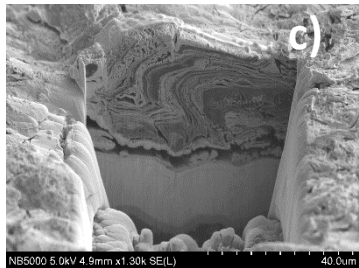
SEM images of the deposit morphology and internal structure, sample J, C4

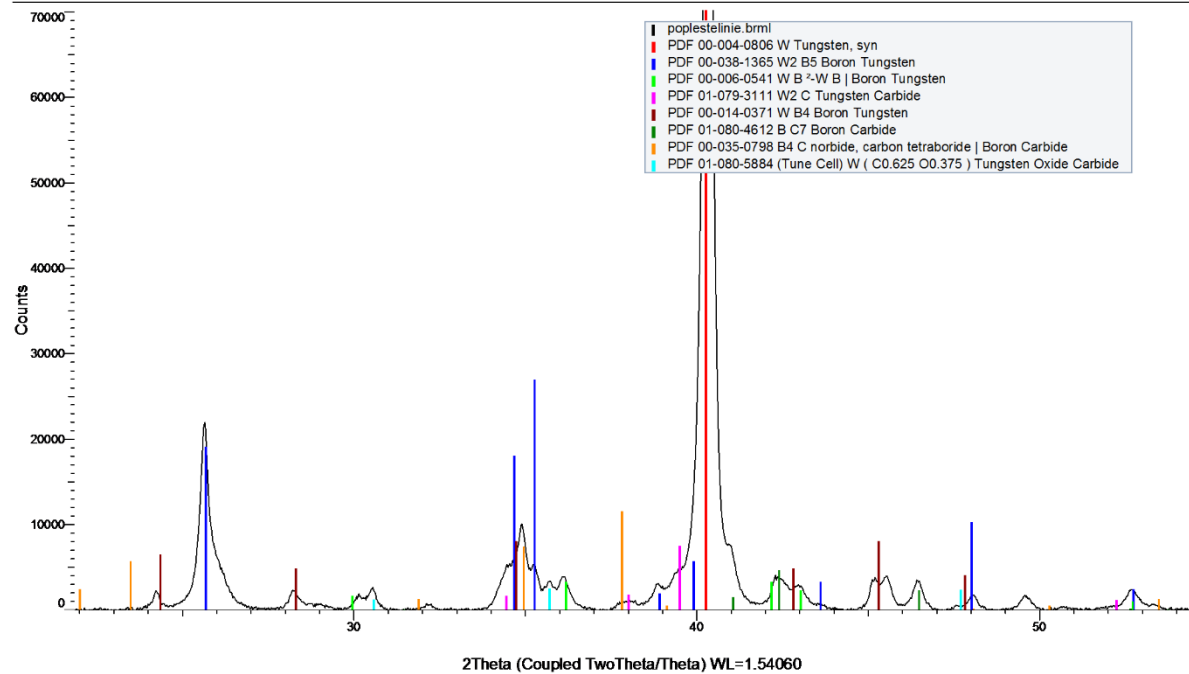
## XRD pattern, sample J, C4.

*The main conclusion that can be drawn from the analysis of this spectrum is the presence of intermetallic phases from the W-B system, tungsten borides.*

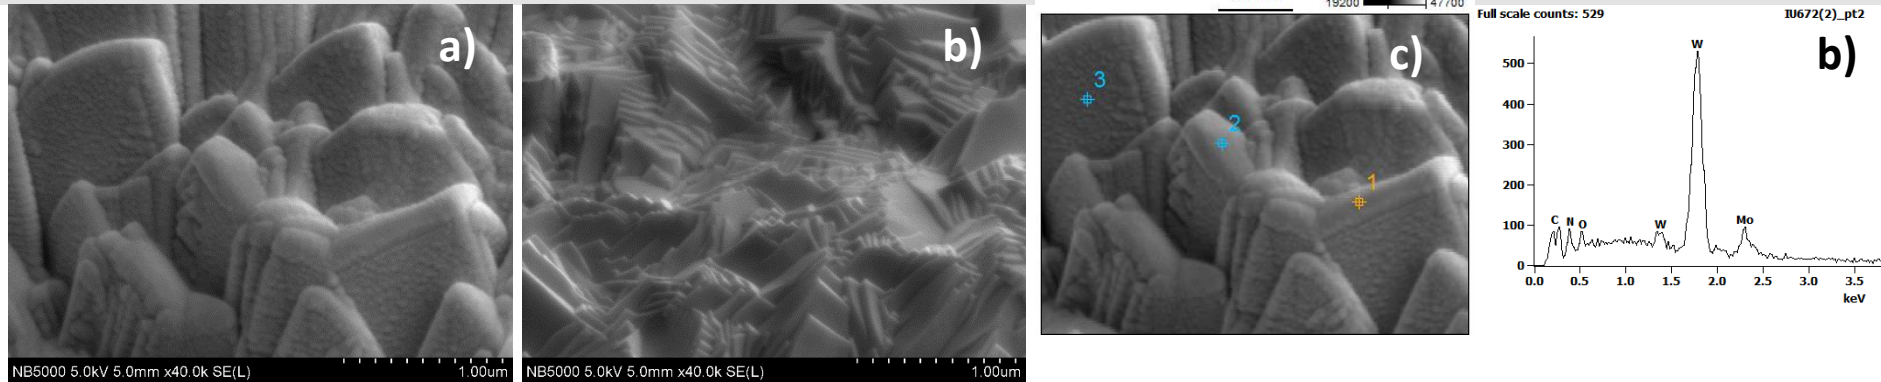
SEM images of the sample IU 672 morphology in the central spot region (a, c) and outside (b) together with the EDS spectrum from the re-deposited material (d). *Re-deposition from the electrode material found.*

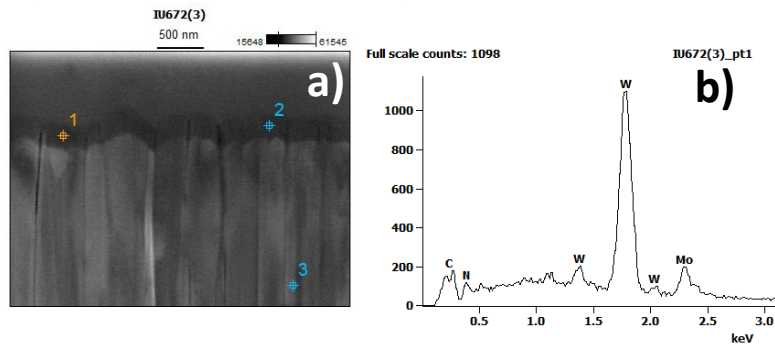
SEM image of the sample IU 672 cross-section (a) together with the EDS spectrum from the surface layer (d), central spot. *Thin layer of re-deposited material found.*
