WP PWIE Meeting 24-27 March 2025

# Analysis of changes in the surface and sub-surface structure of bulk tungsten lamellae and Langmuir probes operating under reactor conditions

Langmuir probes 1, 3, and 5 from module 16W, Tile 5 (removed in 2015)

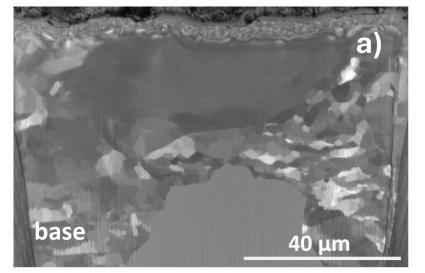
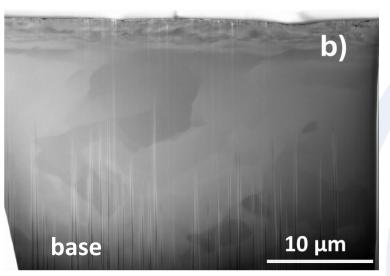
FIB cross-sections of LP-5 base part: a) front and b) back side.

FIB cross-section of LP-5 tip, front side.

- A zone of plastic deformation with a thickness of ca. 3  $\mu$ m was revealed in the base part of the probe.
- The grains visible on the cross-sections made in the base part are approx. 10 μm in size.
- In the tip area equiaxed grains, with a size of the order of 40  $\mu$ m; a heavily deformed zone disappeared.

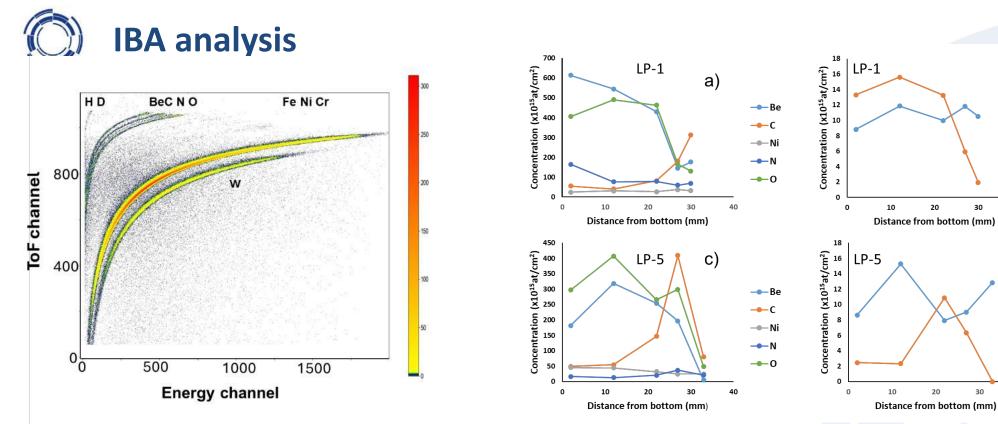
Results of the Langmuir probe analysis with ToF HIERDA

Distribution of deposit elements (a, c) and hydrogen isotopes (b, d) along the length of LP- 1 and LP-5, front side.

• Beryllium and oxygen are the main components of a thin film covering the probes' surface, along with carbon, an admixture of nickel, nitrogen puffed for plasma edge cooling, and hydrogen isotopes.

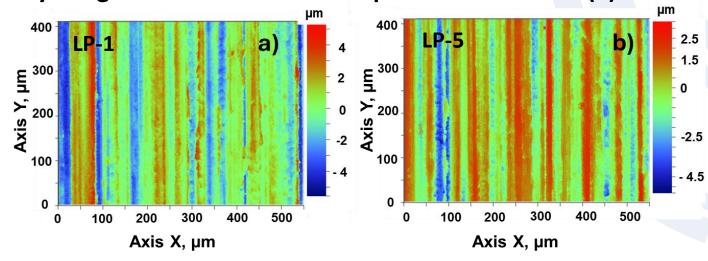
• Roughness values for the tip and the base for the examined probes are at the same level.

#### Exemplary images of the surface development in the base: (a) LP-1 and (b) LP-5.

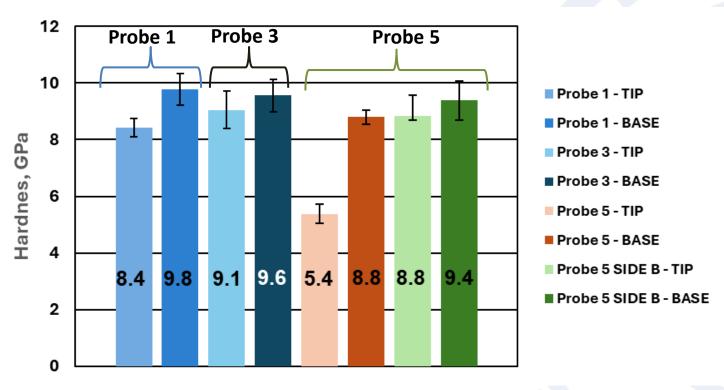
#### Results of nano-hardness measurements

- Large difference in the hardness value in the tip and the base of LP-5 at the front side, 5.4 GPa versus 8.8 GPa, respectively.
- The differences in hardness on the base and tip of LP-1 and LP-3 are small, comparable to those obtained for LP-5 on the back side and its base part on the front side.

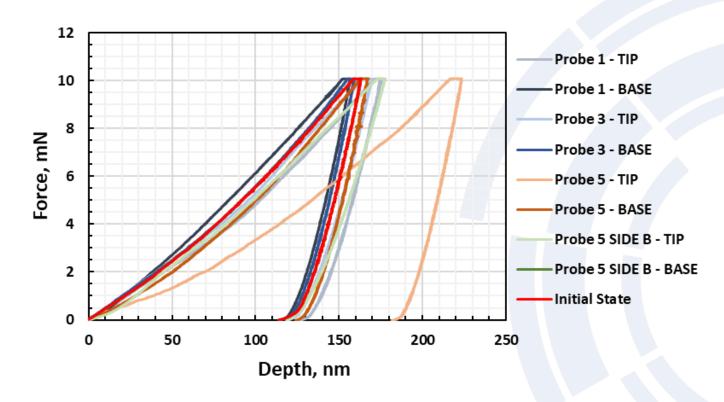
Comparison of force-depth curves for all examined zones

- The only curve that stands out from the others is the one obtained on the front side of the LP-5 tip.
- The results clearly document a high agreement in the mechanical properties of the single probes mounted in the divertor area.

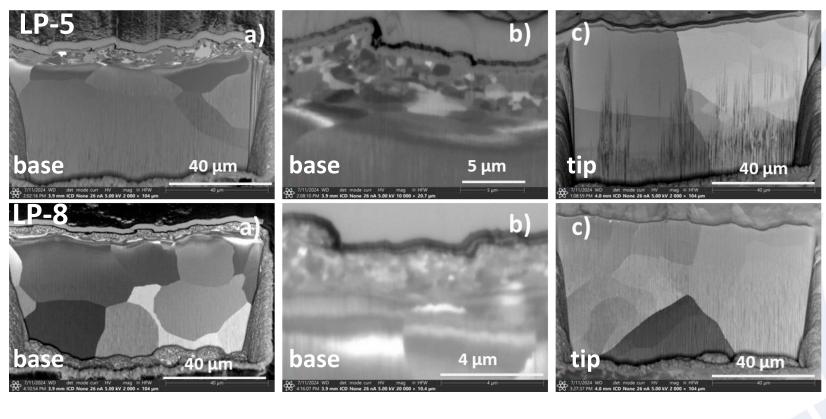
SEM images of the sub-surface FIB crosssections taken in the base (a-b) and the tip (c) of probe LP-5.

SEM images of the sub-surface FIB cross-sections taken in the base (a-b) and the tip (c) of probe LP-8.

- A zone with fine grains near the surface is clearly visible, the so-called "surface deformation zone," observed in the base part.
- A stratified deposit found in the base part. The thickness of the deposit in the case of LP-5 can be estimated at around 0.6 μm.
- In the tip area, the surface deformation zone has disappeared, and the increase in the grain size is noticeable.

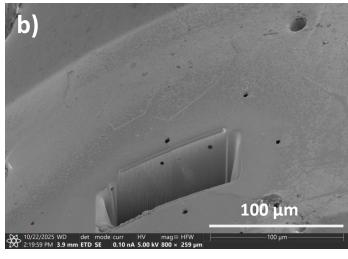
Image of LP7 (a) together with SEM image of the re-solidified zone present at the tip end (b).

✓ Zone with distinct porosity.

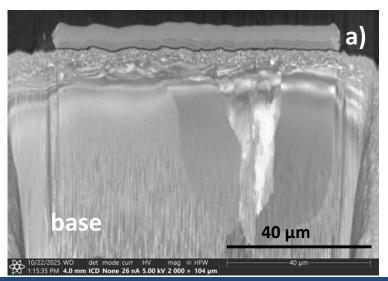
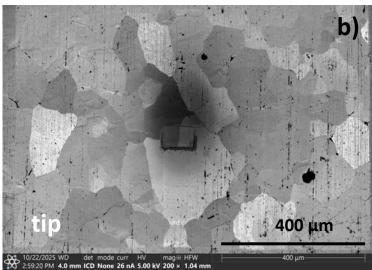
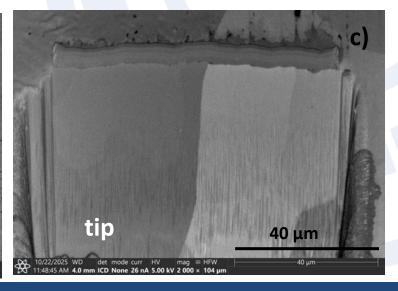
FIB cross-sections of LP-7: a) base and (b-c) tip part (recrystalized zone).

- ✓ At the base surface, a zone of plastic deformation was revealed.
- ✓ A recrystallized zone was observed in the tip area.

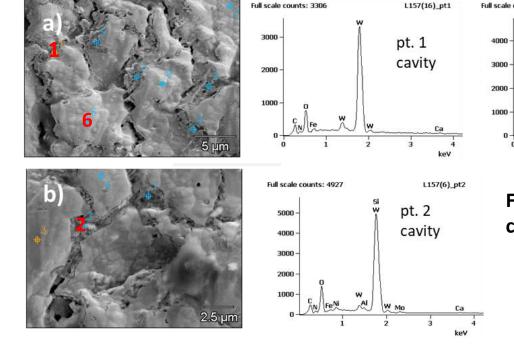
- ✓ Redeposition inside the cracks, locally in the cavities and on edges (shadowed areas).
- ✓ In these areas, we observe material with a different, porous, or stratified structure, sometimes with traces of re-melting.
- ✓ EDX point measurements confirm higher levels of O and C, locally also N, Ni, and Fe in these areas.

Fig. 2. SEM images of lamella 157 surface along with the corresponding EDX spectra.

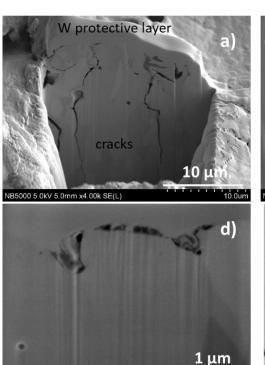
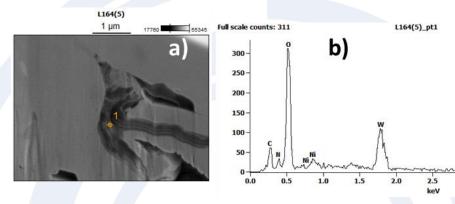
- At the crack mouths, the presence of a material with a different chemical composition than the substrate, Figs. a-b.
- The presence of a thin film of redeposit has been locally revealed, Figs. c-d.
- A zone with changed morphology (likely re-solidified) was observed in some places, Figs. e-f.
- In Fig. e, a structure with a different, porous morphology is shown, Fig. e.
- In the case of sections made in the cavities, the material was almost unchanged, as far as can be determined using the FIB technique.

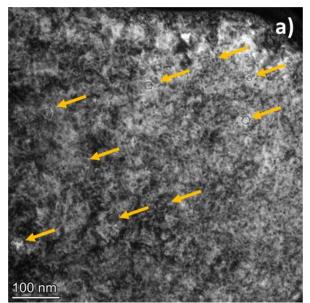
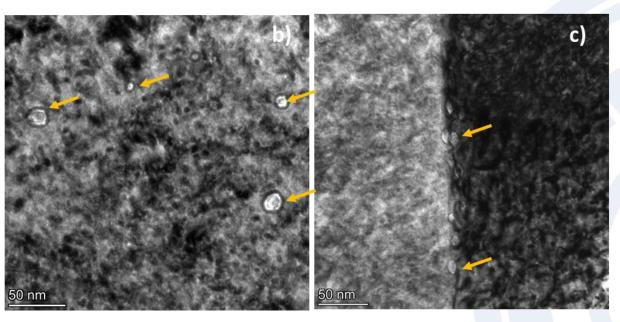
#### TEM images of bubbles present in the subsurface zone of 164 lamella.

- ✓ The bubbles (10-30 nm in diameter) populate the region over 500 nm in depth. They are also present at the grain boundaries.
- ✓ The size and distribution of the bubbles are consistent with what Tokitani observed at not-exposed lamella (Phys. Scr. T171 014010).
- ✓ Those bubbles are considered to be formed during the manufacturing process.

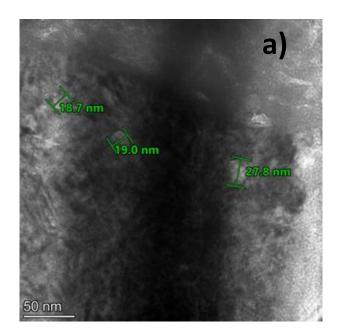
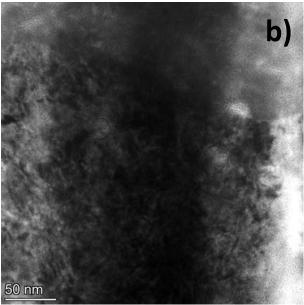
#### TEM images of bubbles present in the subsurface zone of 106 lamella.

Single bubbles (20-30 nm in diameter) found in the near-surface zone of the sample.

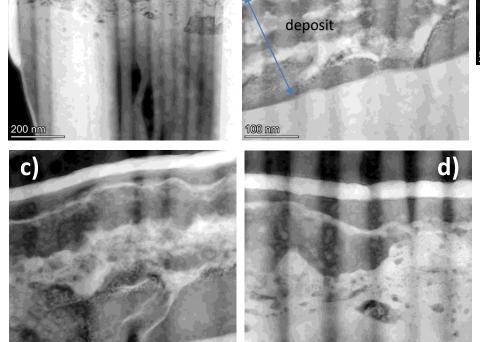
Fig. 1. STEM images of redeposit present at the surface.

- On the surface there is an amorphous, inhomogeneous, porous deposit ~200nm thick.
- Within the deposit there are areas of varying chemical composition, as evidenced by differences in image contrast.
- The intensity distribution can be related to the tungsten content. In the area where linear EDX analysis was carried out, a higher tungsten content was found at the substrate boundary.

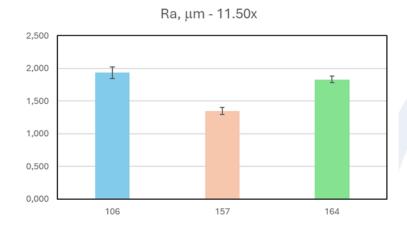
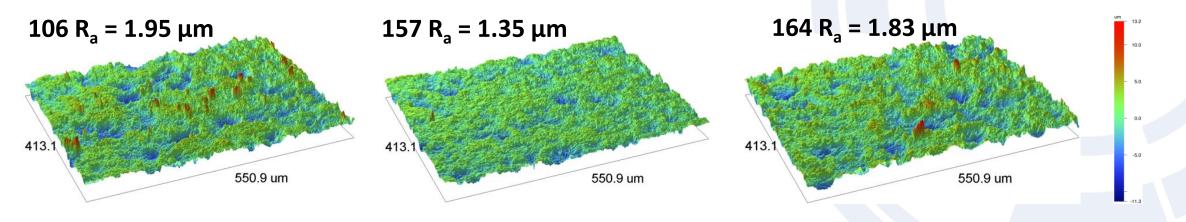
Bar charts showing differences in roughness between samples.

The recorded 3D maps confirm that sample 157 has lower roughness. The differences in height between the lowest and highest areas are noticeably smaller (mag. 11.5x).
