EUROfusion PSD Management Meeting

WPSA report 2026-02-10

Carlo Sozzi

Div VUV inspection

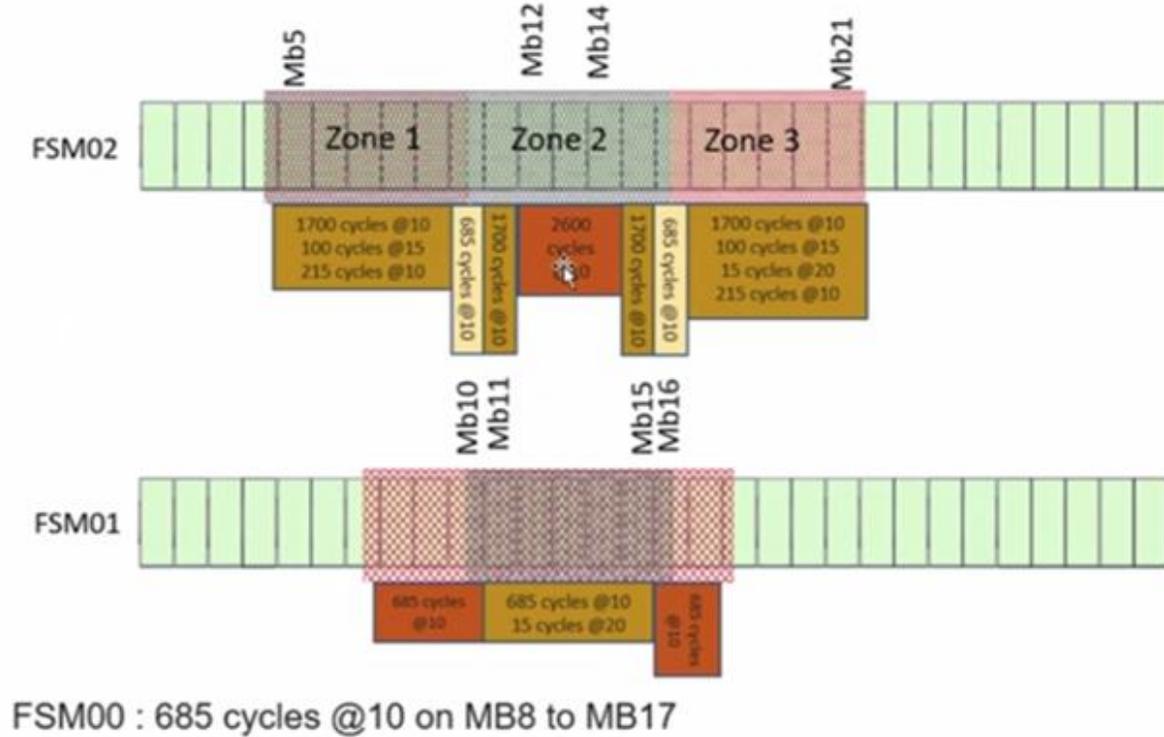
Recap on FSM

Full scale HF divertor tiles mock-up test successful in HADES

FSM02

- 2600 pulses at 10MW/m²
- 100 pulses at 15MW/m²
- 15 pulses at 20MW/m²

FSM01

- 685 pulses at 10MW/m²
- 15 pulses at 20MW/m²

FSM00

- 685 pulses at 10MW/m²

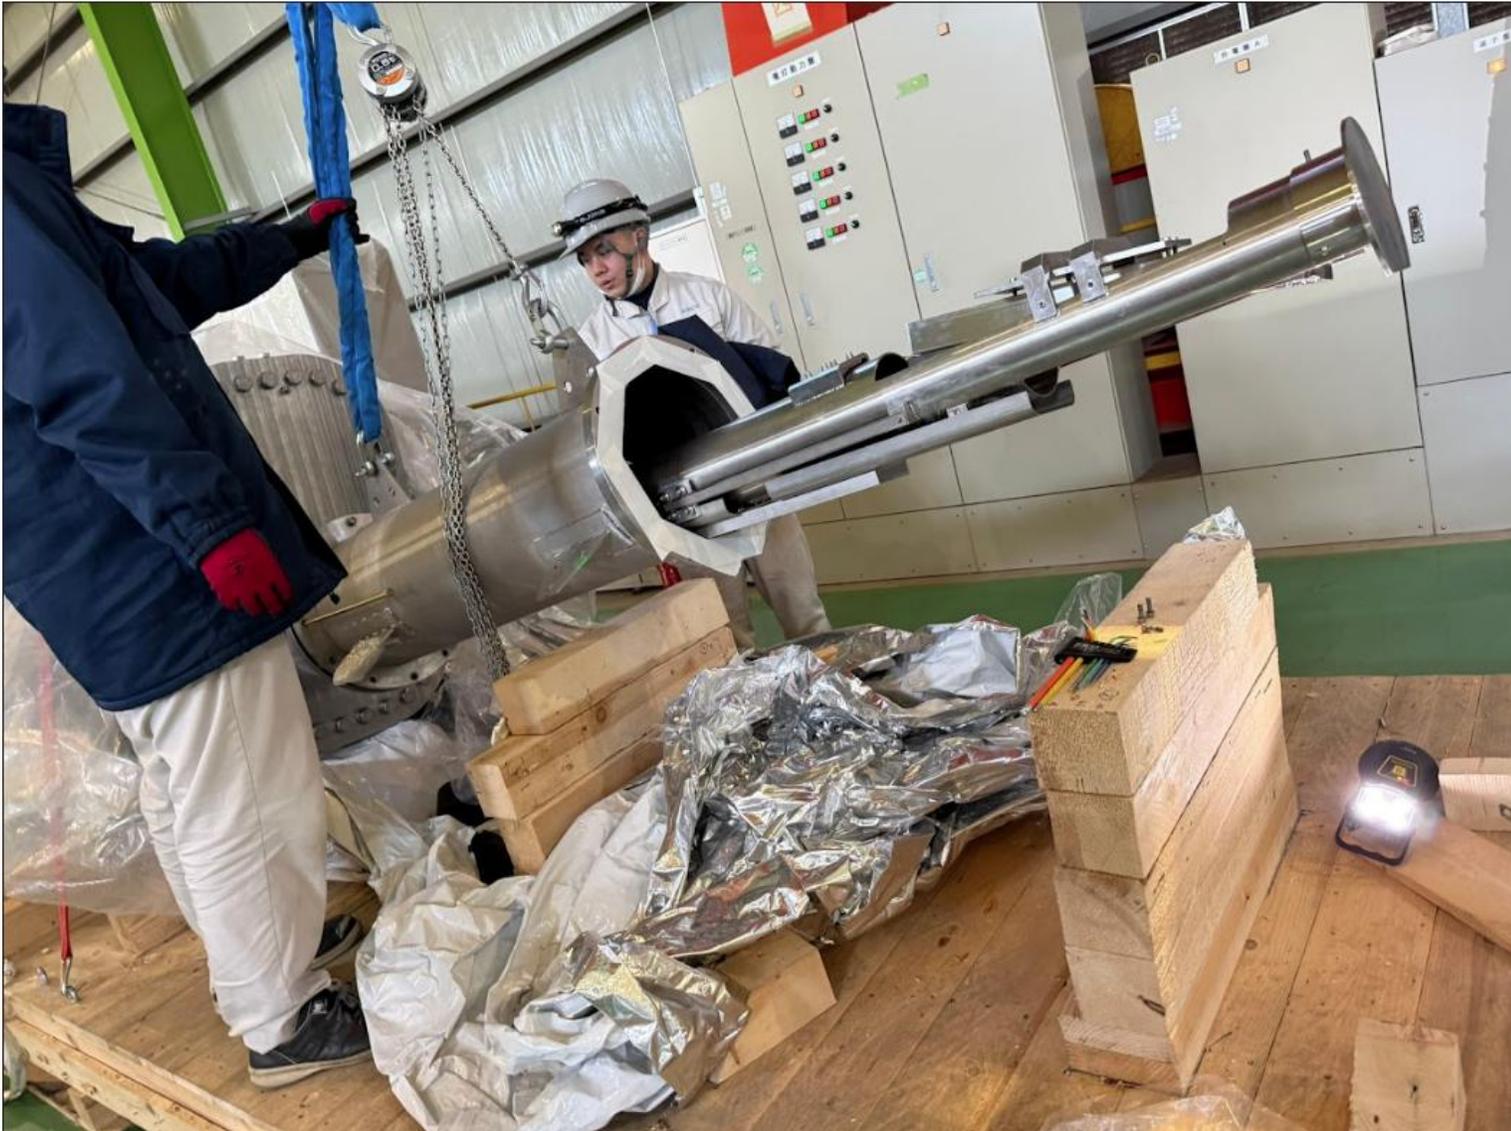
- Port plug nearly touching the test vacuum chamber during the extraction
- Strong stress applied to the welding, visual inspection required
- Visual inspection to check the status after transportation also completed

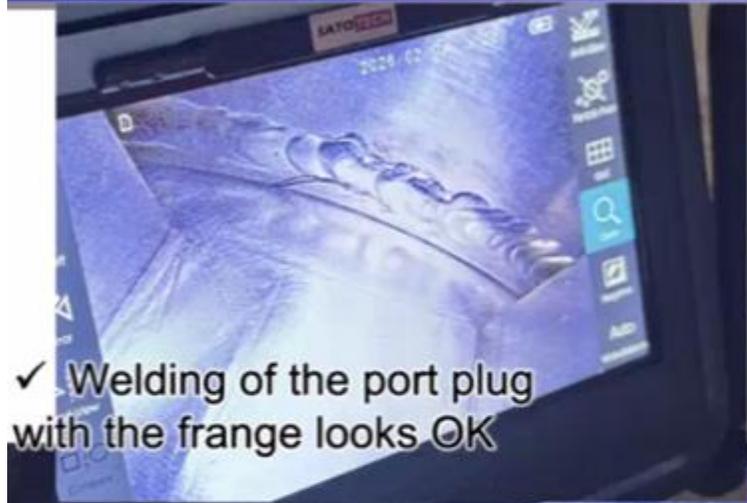
✓ Welding of the port plug with the frange looks OK

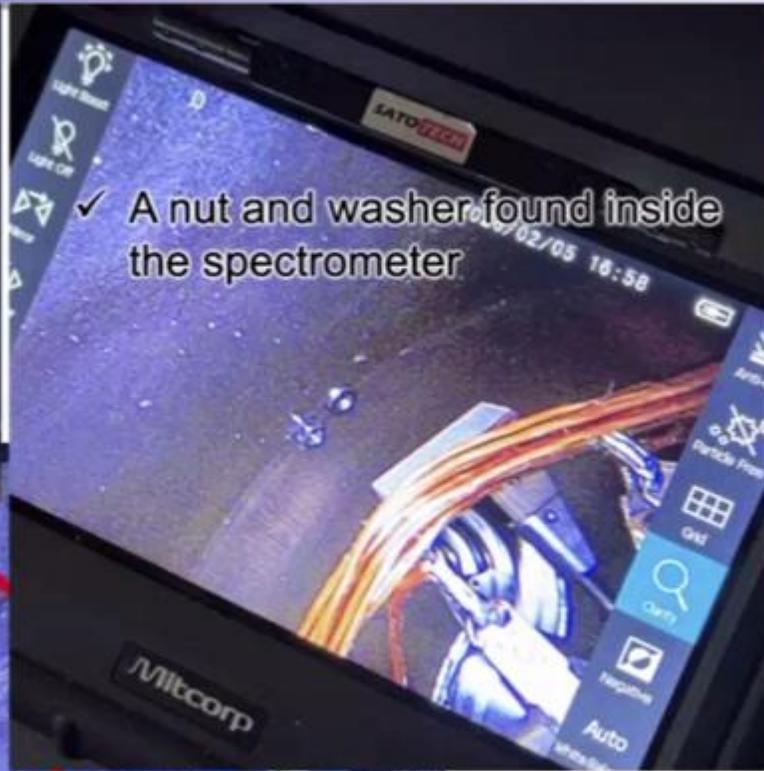
✓ A nut and washer found inside the spectrometer

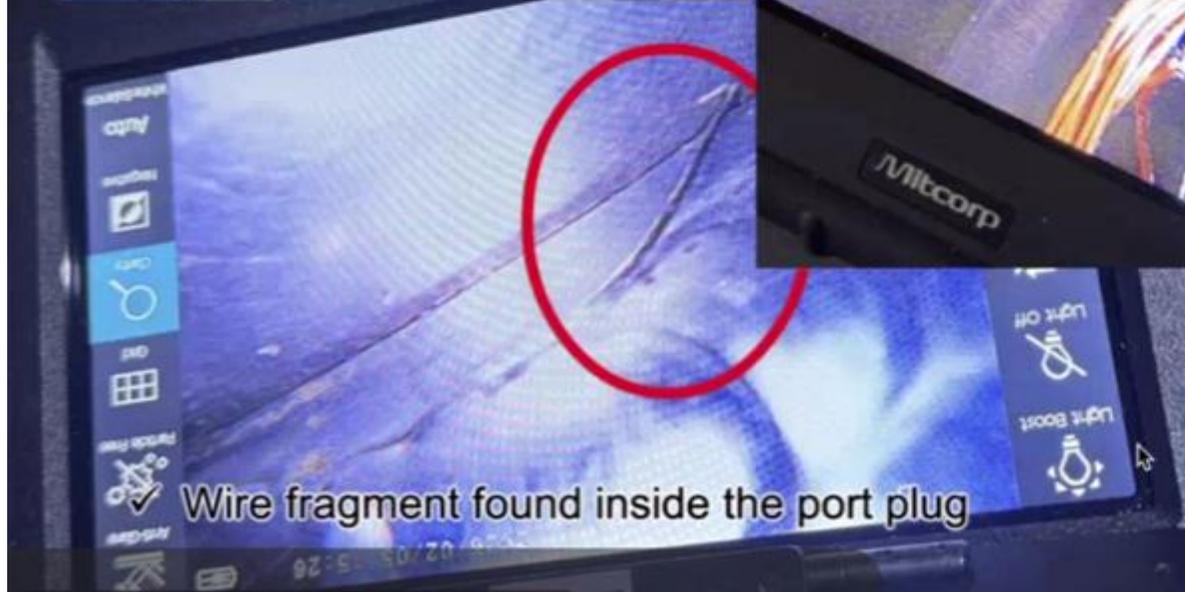
Wire fragment found inside the port plug

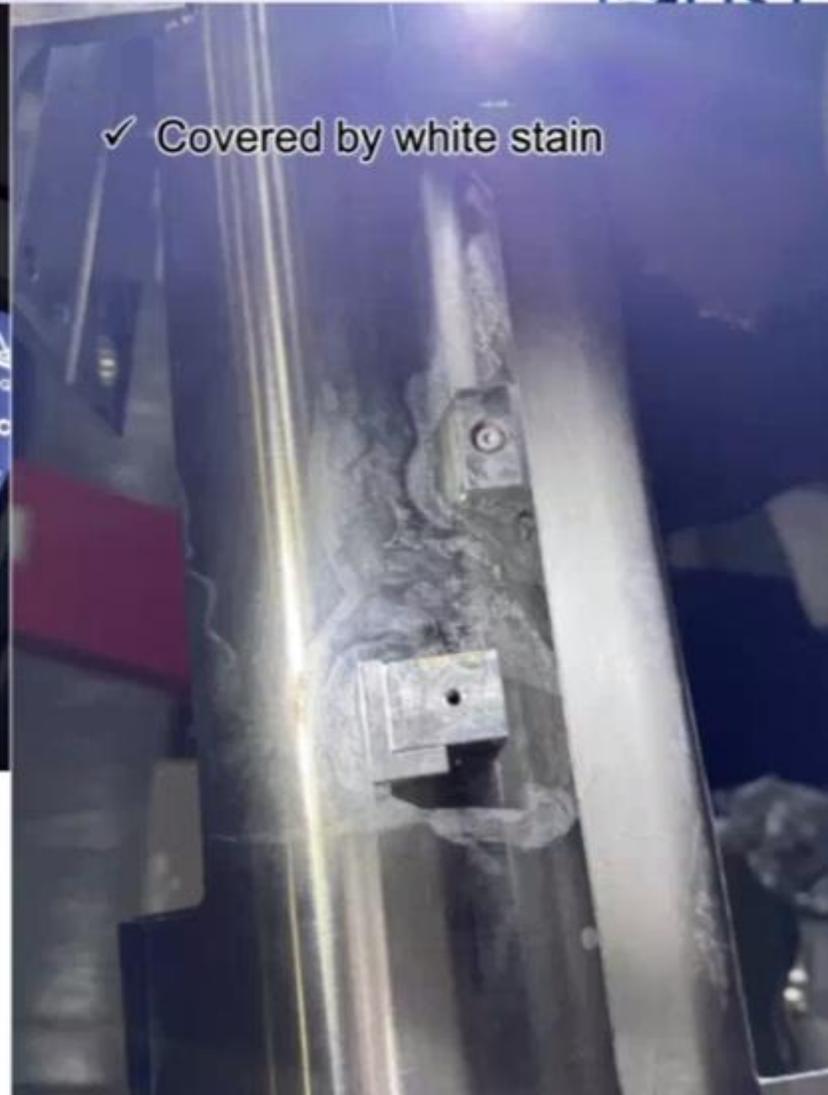
✓ Covered by white stain
