## SP B.3: Characterization of plasma-exposed materials

**Task:** Determine erosion, deposition, and fuel retention on selected wall tiles from AUG and WEST

**Deliverable:** Surface analyses of selected AUG and WEST wall tiles

Jožef Stefan Institute, Ljubljana, Slovenia

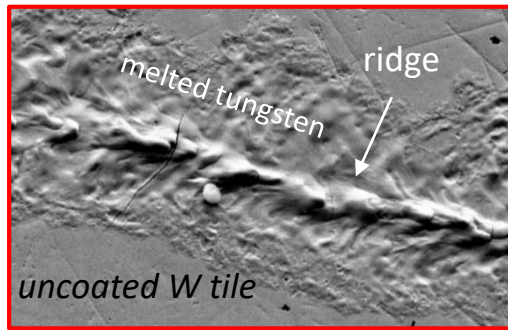
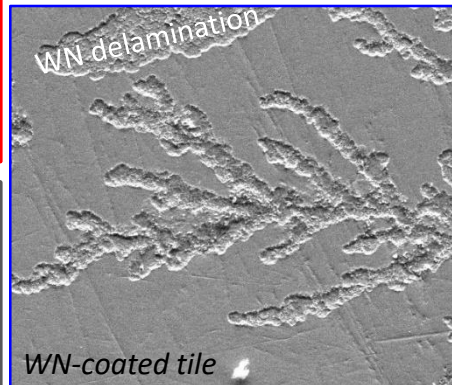
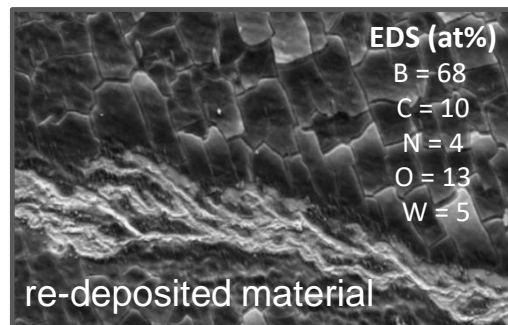
- **arc traces cover** around **10%** of the surface area
- on **uncoated W tile** arcing causes W melting and formation of ridges in the center of arcs traces
- on **WN-coated area** arcing mainly causes delamination of the WN-coating
- on **deposited material** arcing removes large parts of deposits due to poor adhesion

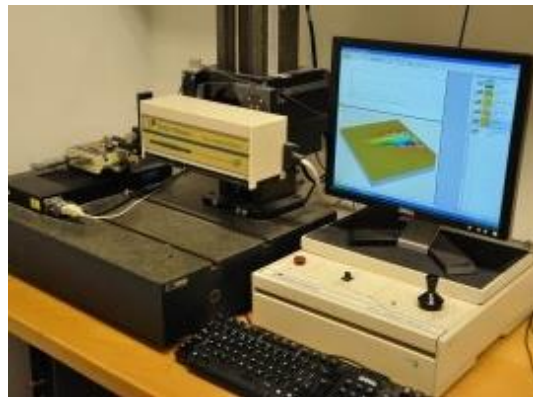
*stylus profilometer*

Taylor-Hobson, Talysurf

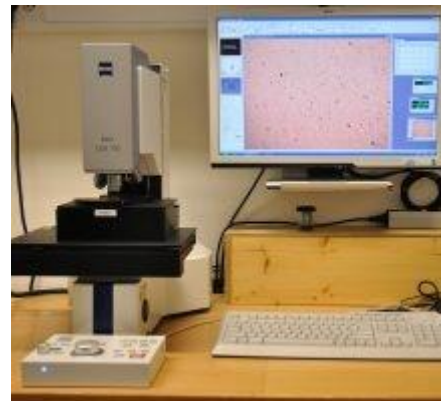
*optical microscope*

Zeiss Axio CSM 700

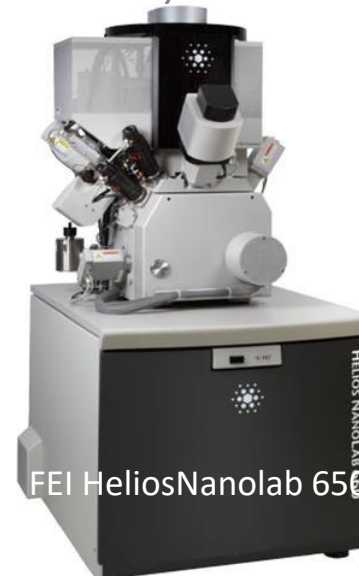
*SEM/FIB*

FEI HeliosNanolab 650

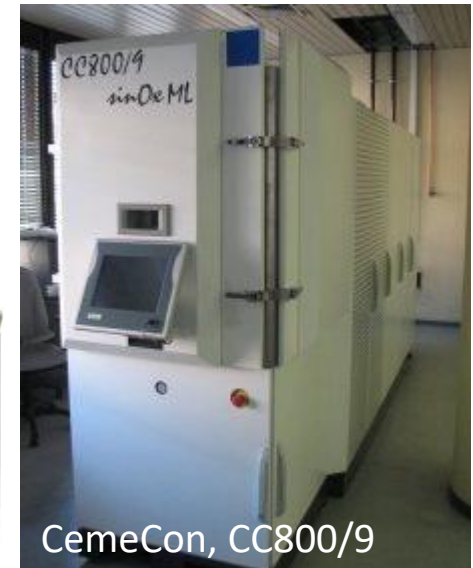
*magnetron sputtering*

CemeCon, CC800/9
