# Broad-beam RBS/NRA results: overview of erosion/deposition patterns (MPG)

Martin Balden & Matej Mayer, IPP

# SEM/EDX results for overview of surface modifications (MPG)

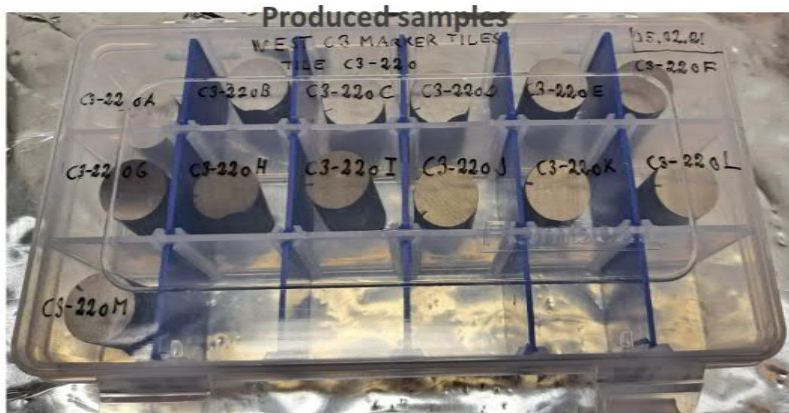
- ❖ C3 marker tile cut into smaller pieces for further analyses
