SPA Activities DIFFER 2022

SPA Activities at DIFFER 2022

Pre-crack damage evolution and erosion under transient loading

Influence of slow transient plasma loading on tungsten monoblocks

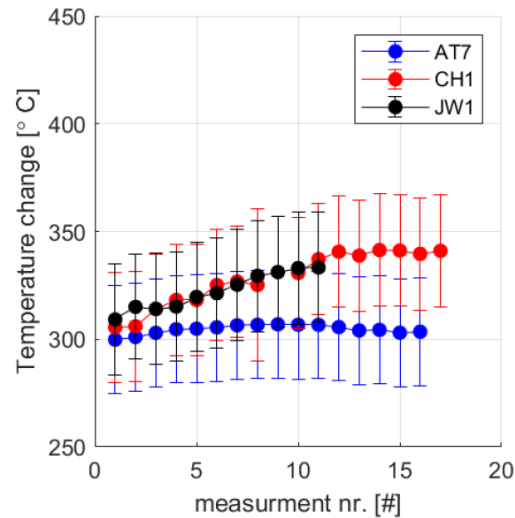
800 °C 6 MW m⁻² s^{0.5}

Observed changes

No emissivity change

Max $\Delta T_f / \Delta T_0 = 12\%$

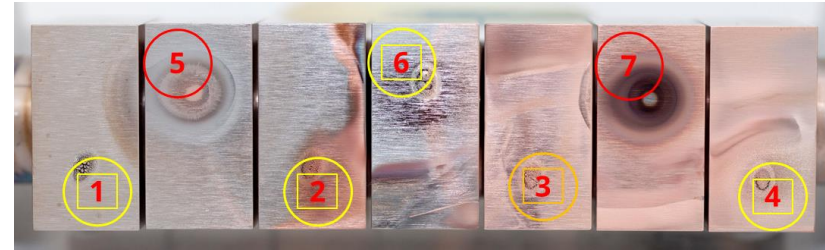
Laser spots: roughness

Extremely roughened/cracked laser spots

Localized melting

- Very strong increase in roughness in laser-spot location -> thermal isolation and erosion/droplet risk?
- Sputtering and re-deposition leads to strong surface morphology changes -> further investigation

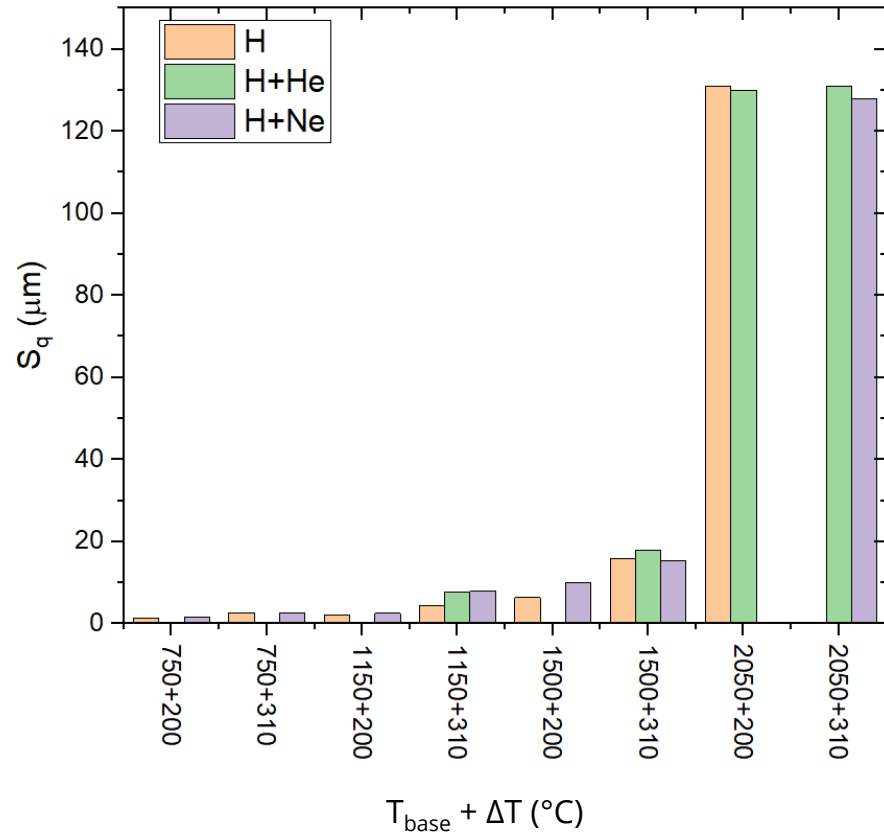
Roughness comparison

Severe deformation for very small ELM-like loads
($F_{\text{HF}} \sim 4 \text{ MW m}^{-2 0.5}$)

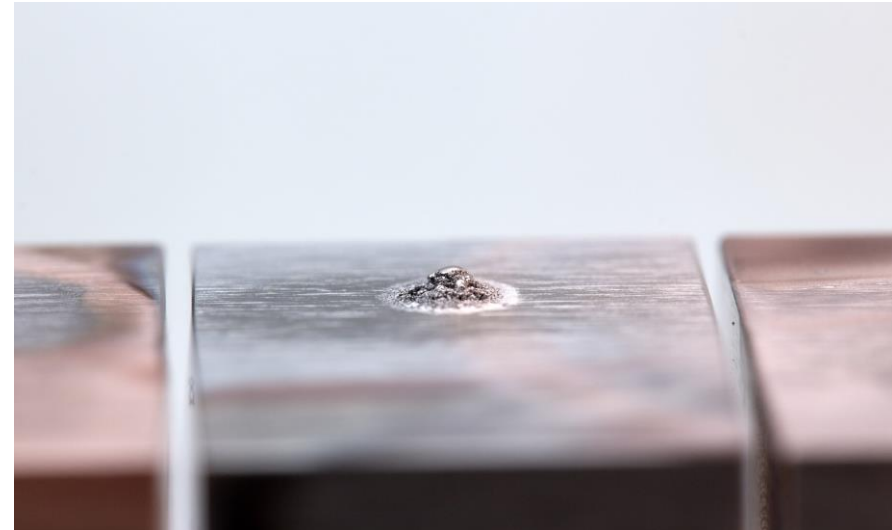
Strikepoint protrusion = erosion risk?
