WP PWIE SP B.2 & SP B.3, project meeting 2022 report on analyses of WEST PFCs and perspectives for 2023

Mathilde DIEZ (CEA)

February 07, 2023

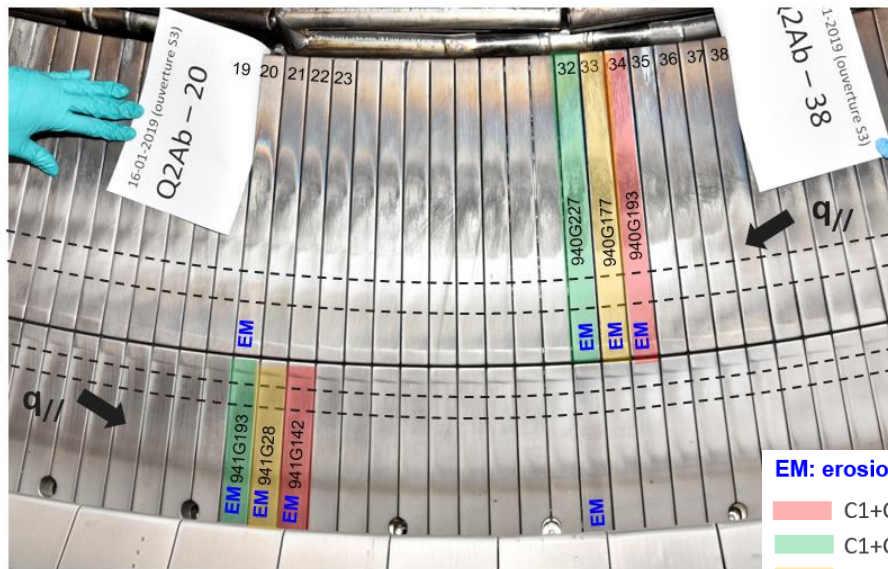
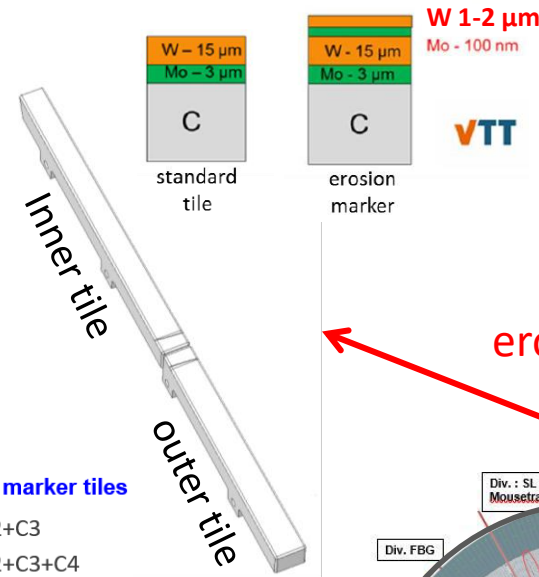
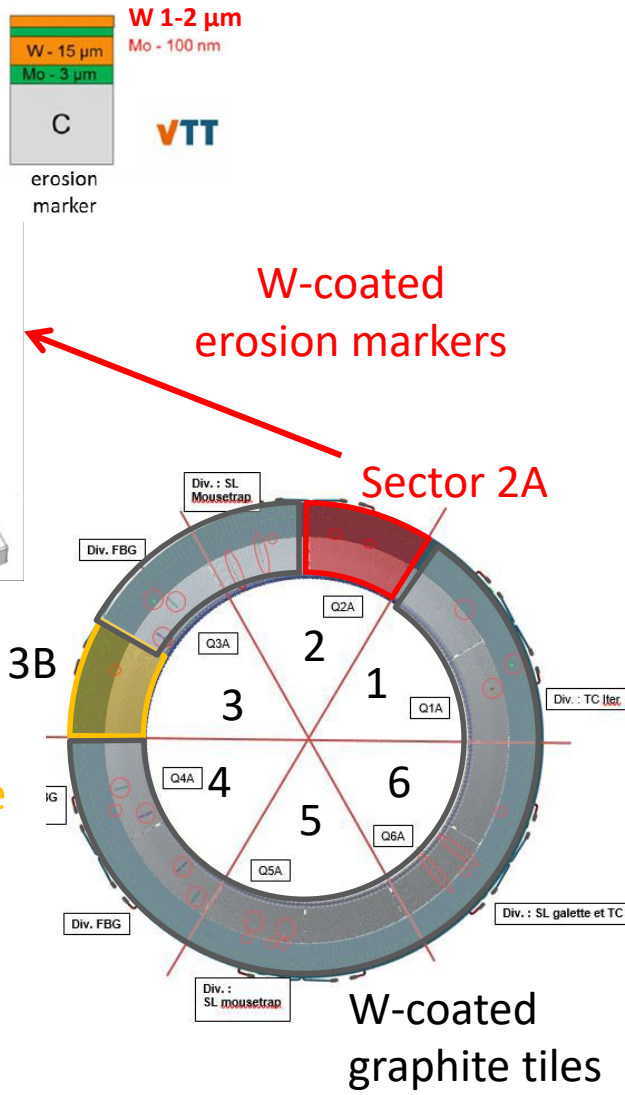
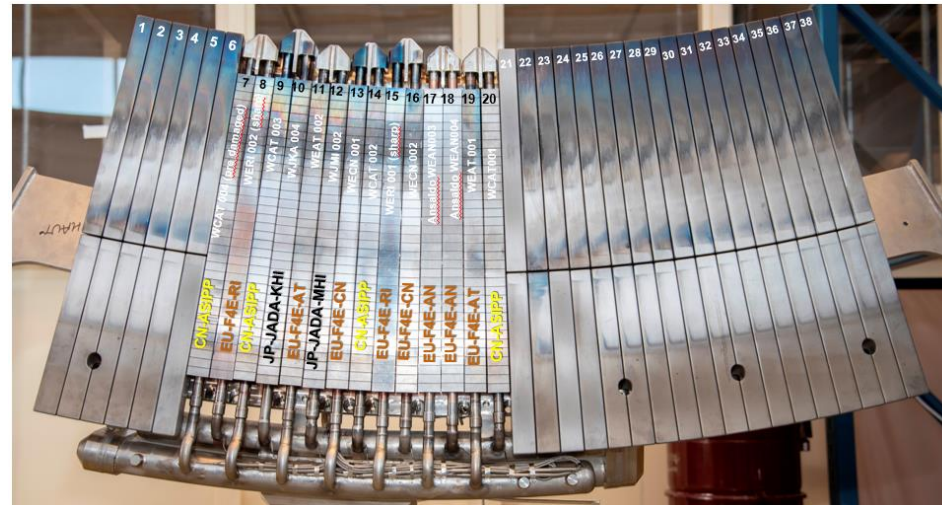
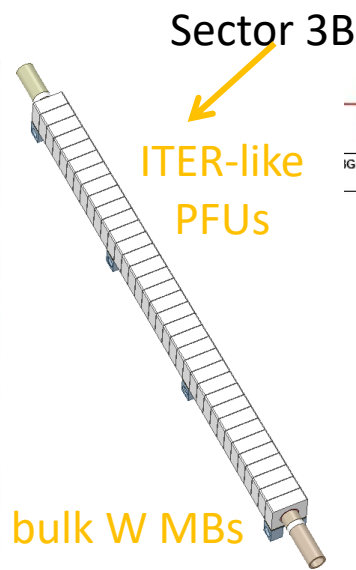
Reminder: divertor tiles installed in WEST during phase I

- EM: erosion marker tiles
- C1+C2+C3
 - C1+C2+C3+C4
 - C1+C2+C3+C4+C5

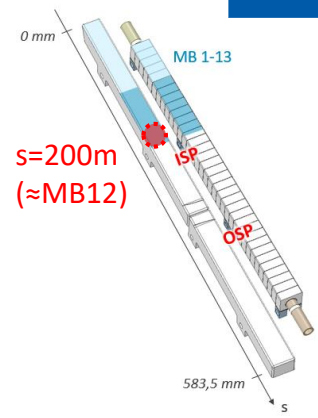
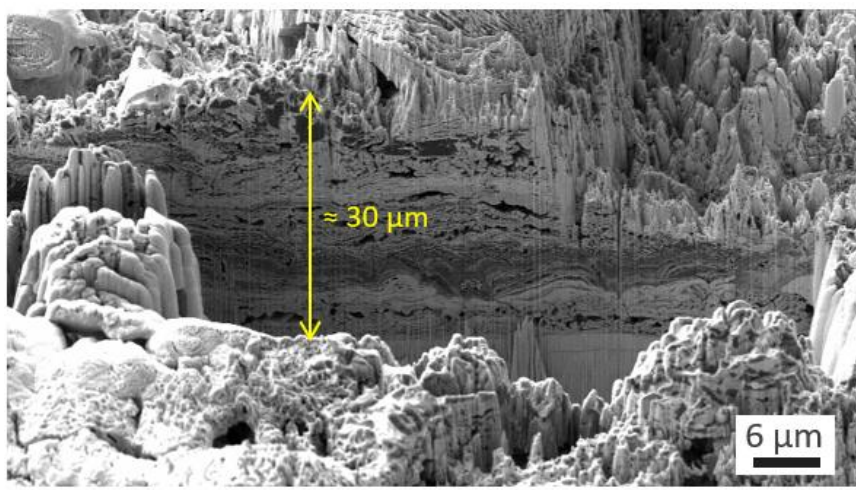
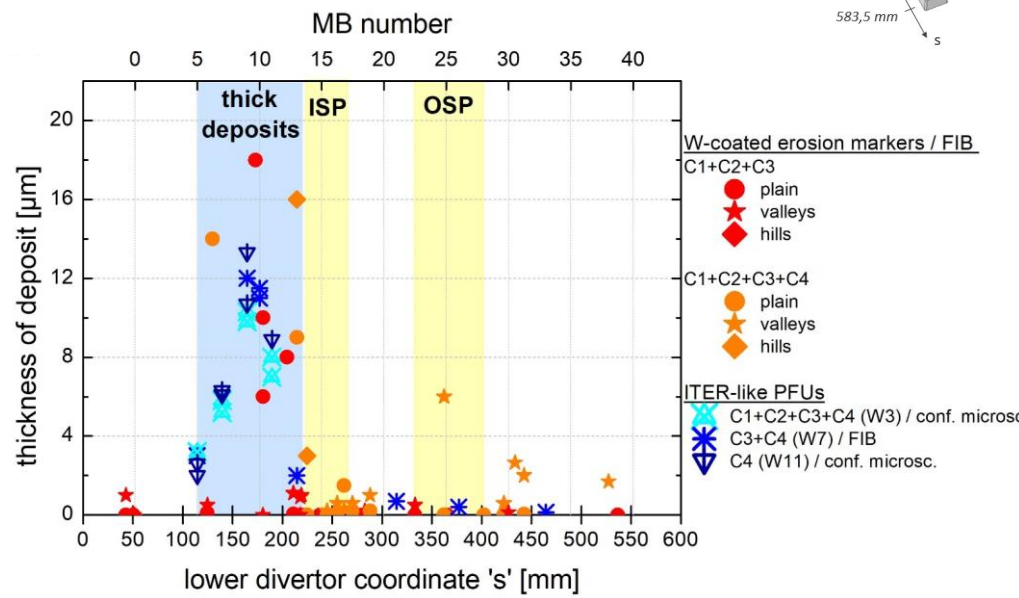
Erosion marker tile exposed to C1+C2+C3+C4+C5
 $s=200 \text{ mm}$

2022: SEM/EDS/FIB analysis of C5 erosion marker tiles

- ▶ After C5, up to 30 μm of deposited layers
- ▶ ($\approx 7\text{h}$ of plasma \rightarrow net deposition rate $\approx 1,2 \text{ nm/s}$)

- ▶ To be compared with (2021):
 $\approx 10 \mu\text{m}$ after C3
 $\approx 15\text{-}20 \mu\text{m}$ after C4

→ Results to be further analysed and to be confronted with the analysis of standard tiles exposed to C4 only (next slide)

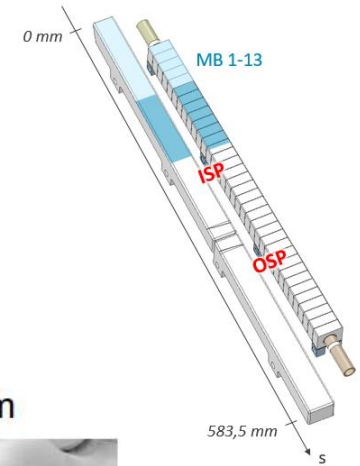
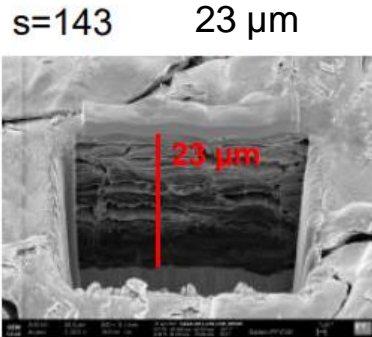
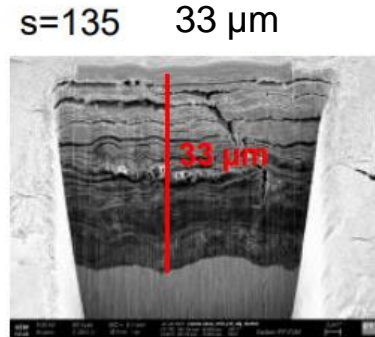
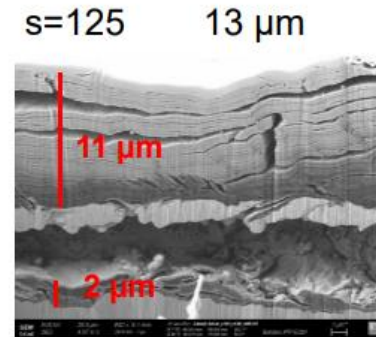
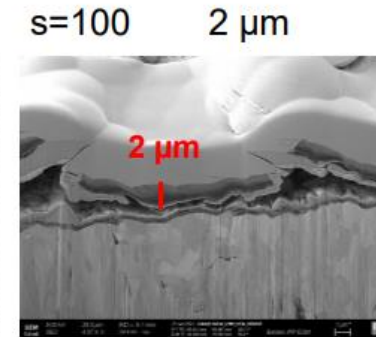
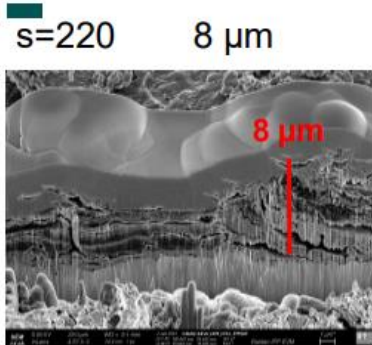
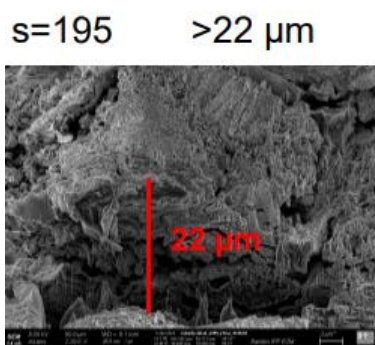
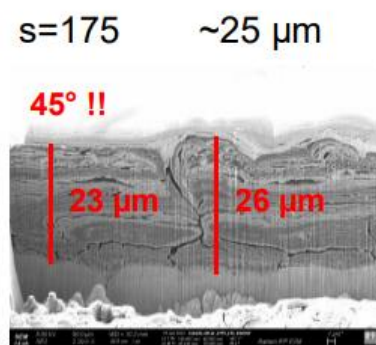
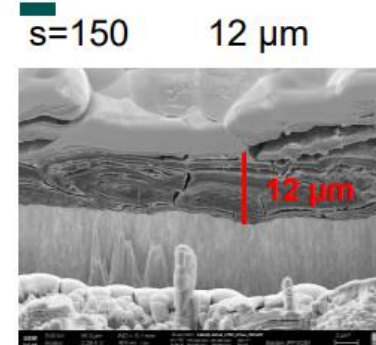
2022: SEM/EDS/FIB analyses of standard tiles exposed to C4 only

- ▶ After 1 campaign only, deposited layers up to $\approx 30\mu\text{m}$

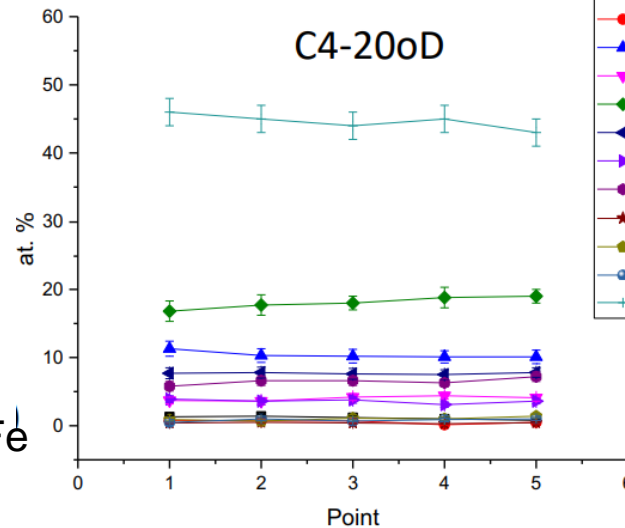
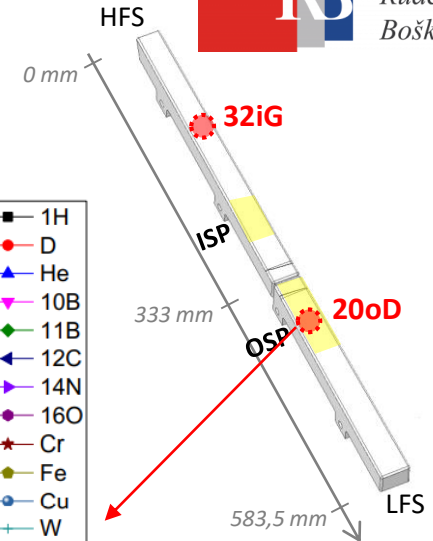
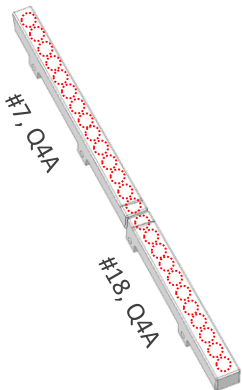
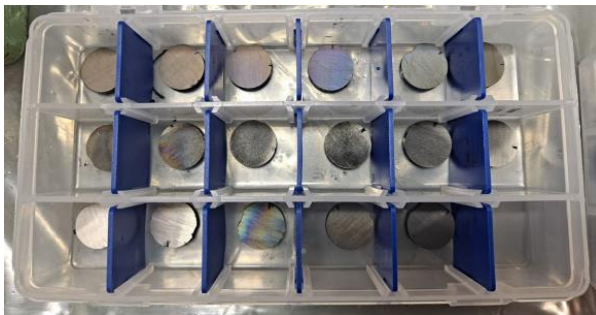
Helium detected in the OSP of C4 marker tiles!

IBA (Tof-ERDA) performed at RBI on:

- ▶ sample “32iG” (deposition area)
 - H, D, B, C, N, O, Cr, Fe, Cu, W
- ▶ sample “20oD” (OSP)
 - 45% W
 - 15-20% B
 - 10% He
 - rest : <10% C, O, H, D, N, F, Cr, Fe

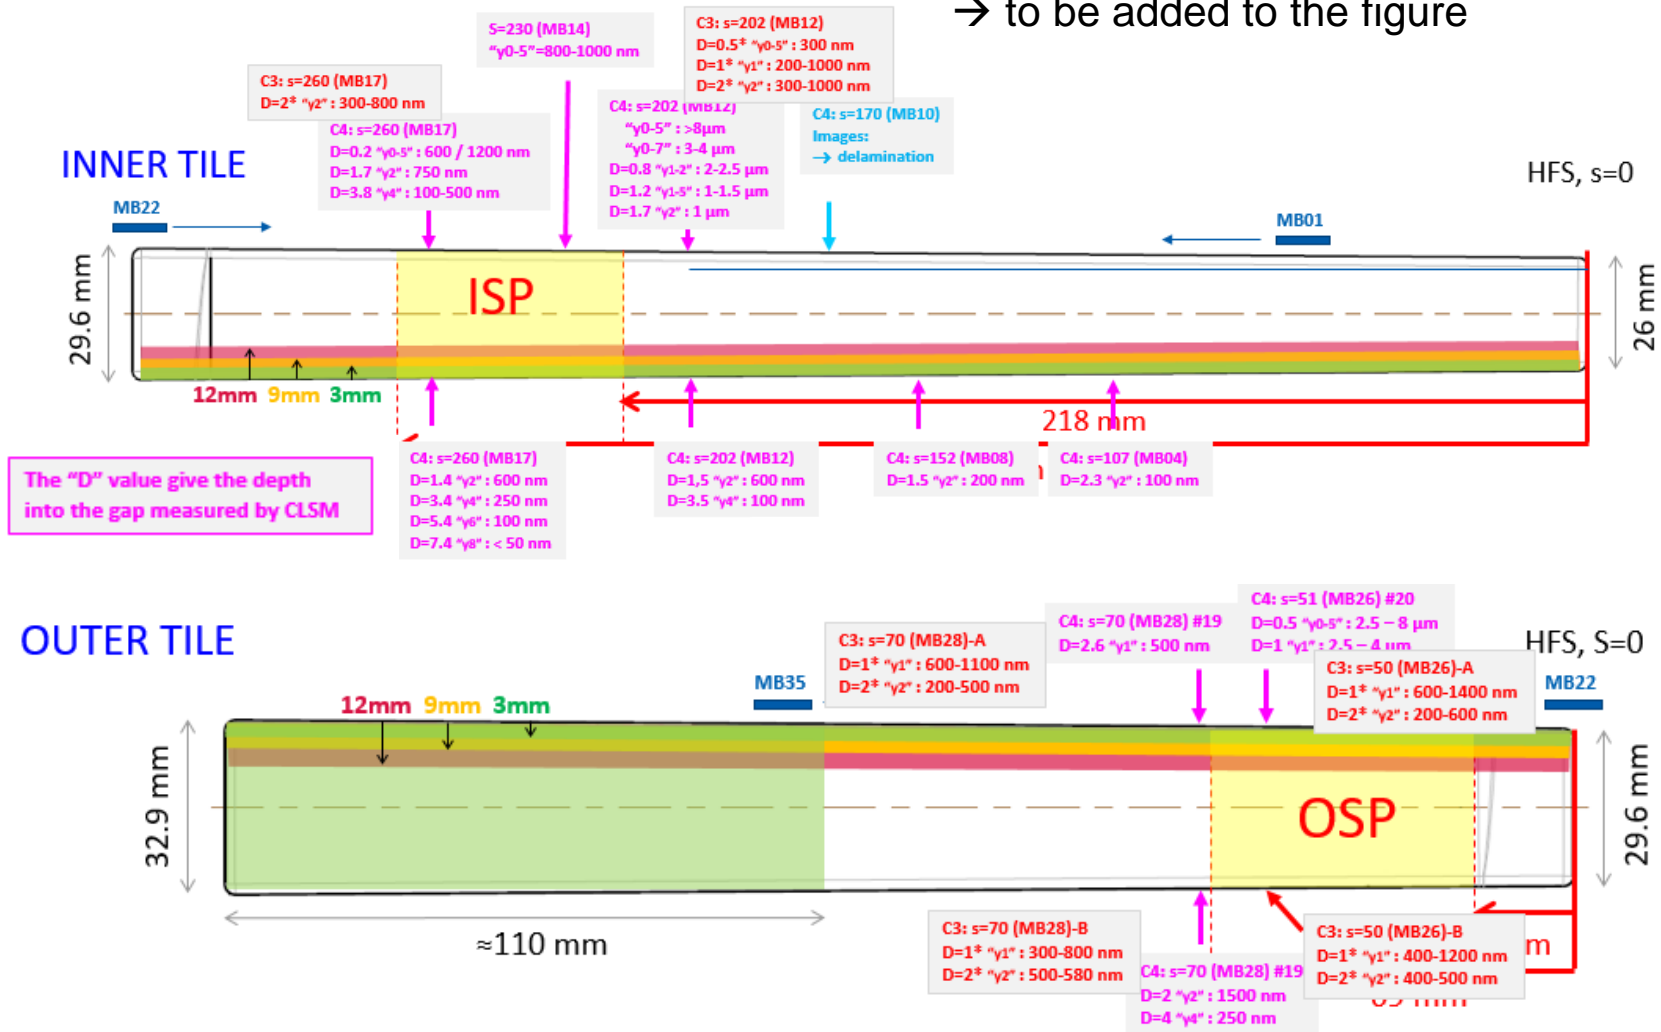
Deposited layers found deep into the gaps...

Goal: determine and compare thickness of deposited layers into the gaps on C3, C4, C5 marker tiles

2022: data measured on C5 marker tiles
→ to be added to the figure

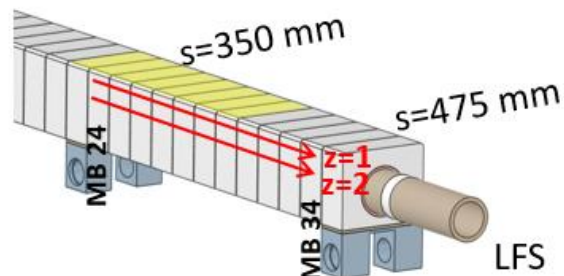
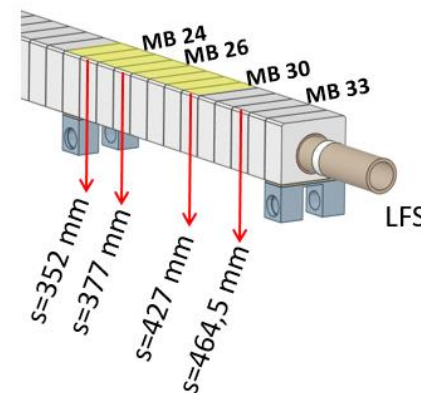
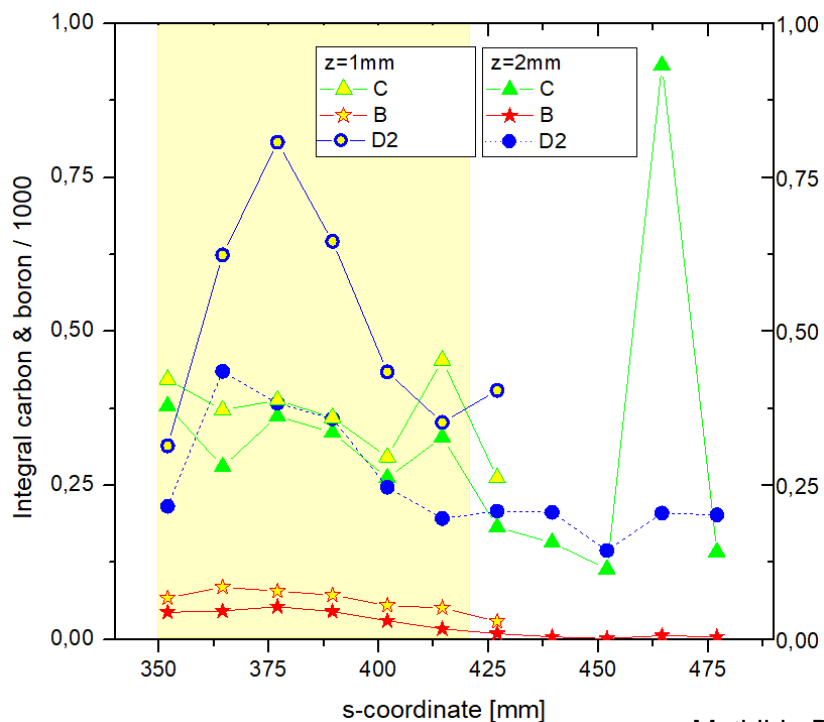
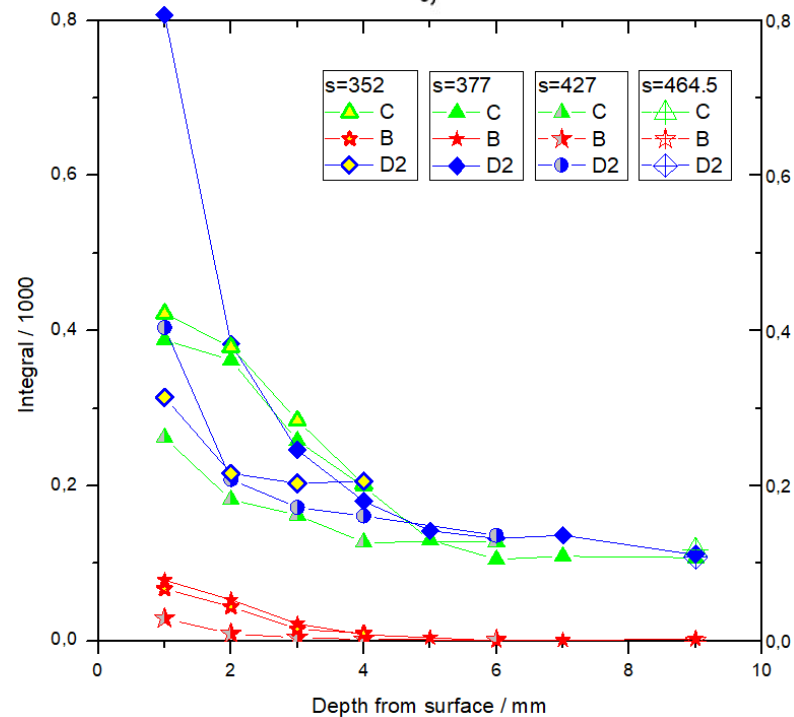
... with C, B, D light impurities content

Goal: determine content of deposited layers into the gaps on ITER-like PFU

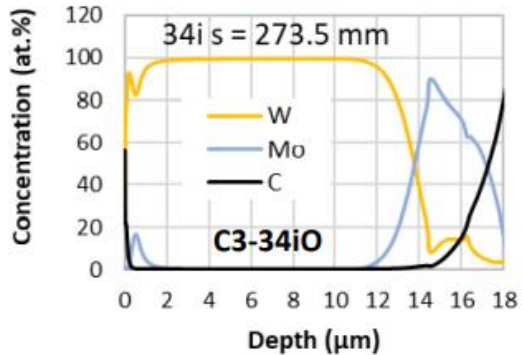
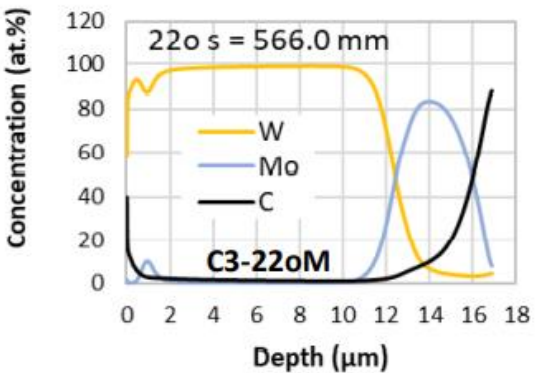
GDOES

LIBS/GDOES/SIMS cross-analysis successfully conducted on C3 samples !

- ▶ Comparison made between GDOES, SIMS and LIBS
- ▶ Detailed depth-profile characterization of the deposits

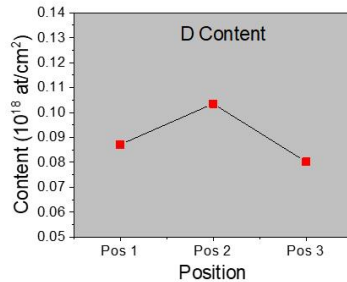
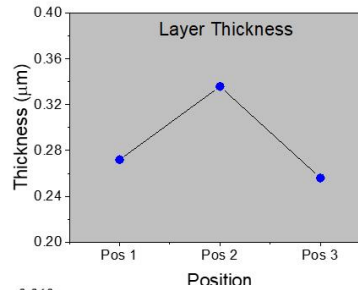
Goal: investigation of surface erosion (RBS/NRA)

120 μm Mylar between target and detector
 $^2\text{H}(^3\text{He}, p_0)^4\text{He}$: V. Kh. Alimov et al C. S. data

Beam: ^3He
 Energy: 2 MeV
 Detection Angle: 135°

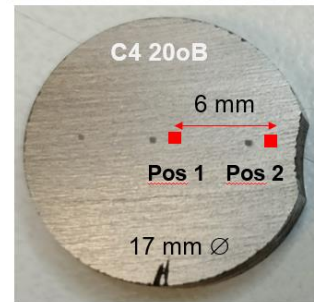
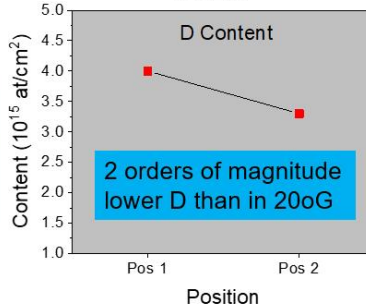
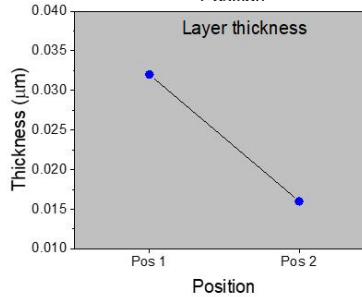
D layer thickness
 $\approx 0,3 \mu\text{m}$
 Erosion of $0,5 \mu\text{m}$
 evidenced after C3

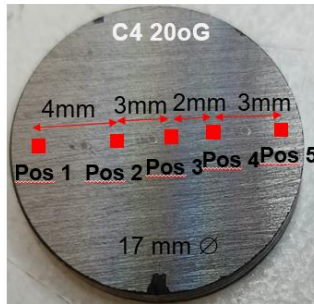
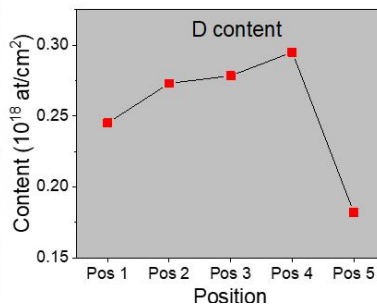
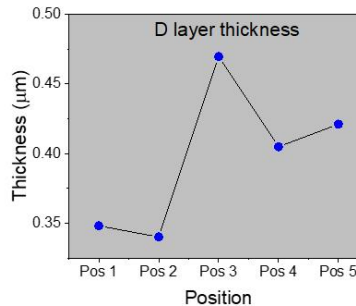
D layer thickness
 $\approx 0,025 \mu\text{m}$

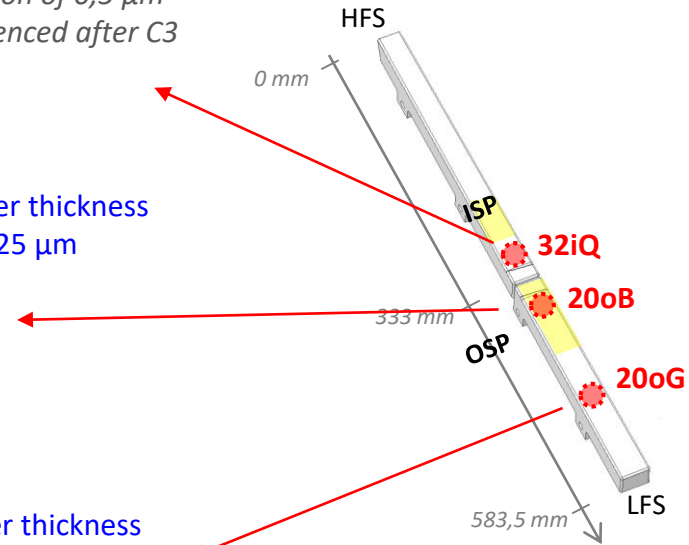
D layer thickness
 $\approx 0,4 \mu\text{m}$
 No erosion evidenced after C3

- D less present in OSP erosion dominated area
- max D content $\approx 0,3 \cdot 10^{18}$ at/cm² in shadowed region

→ Results in good agreement with those obtained on the full C4 marker tile [M. Balden et al., 2021]

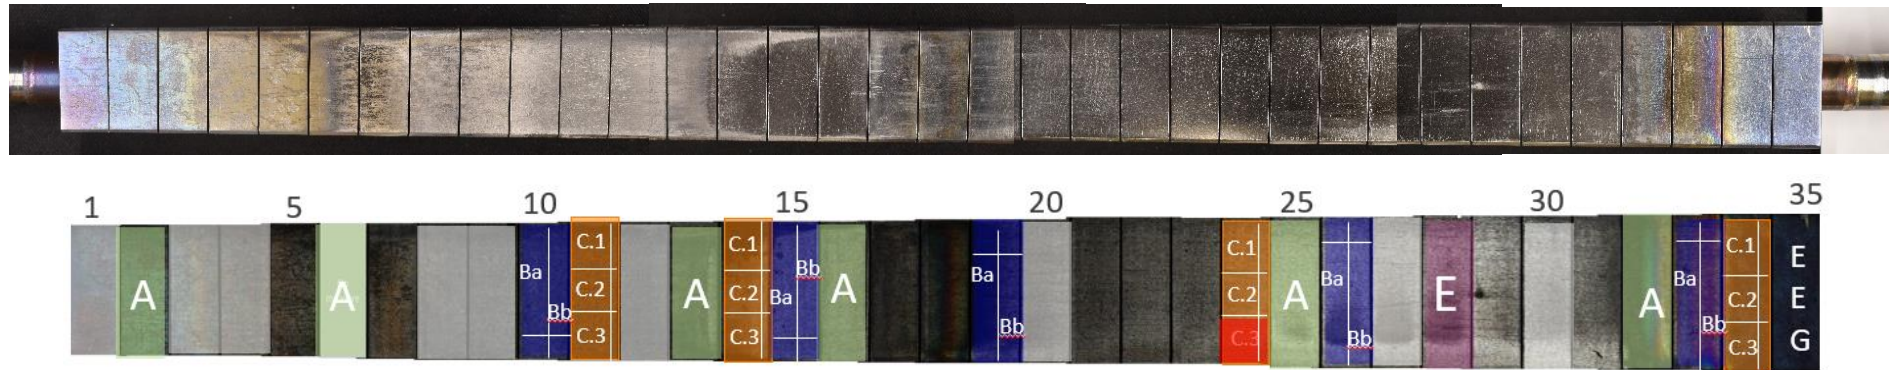
Distribution matrix of C3+C4 ITER-like PFU#13

The W monoblock sample analysis in 2023 is organized as follow:

- ▶ **Batch A:** composition variation on the plasma exposed surface
- ▶ **Batch B:** He and microstructure
- ▶ **Batch C:** fuel retention
- ▶ **Batch D:** optical hot spots
- ▶ **Batch E:** surface modification along the toroidal direction

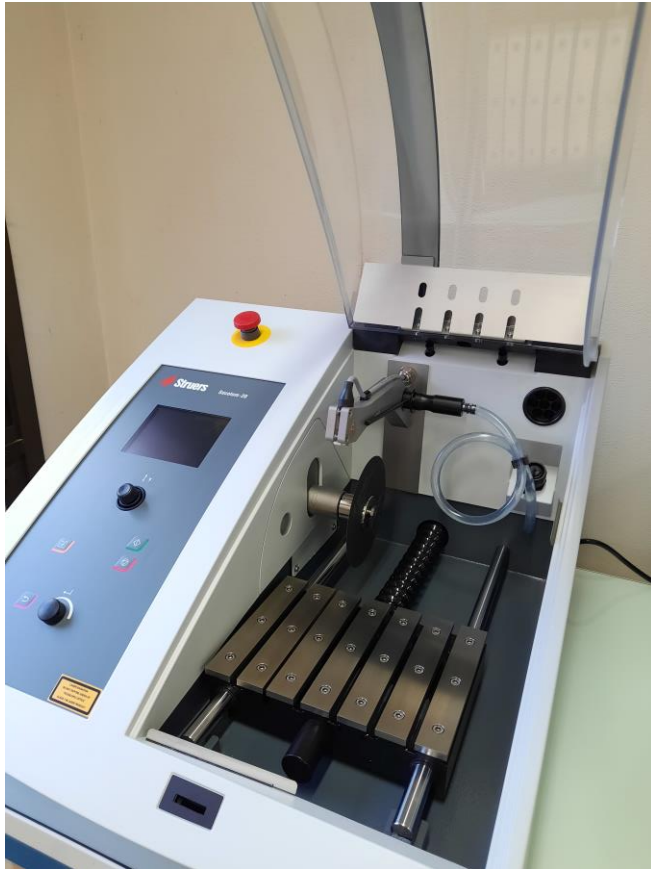
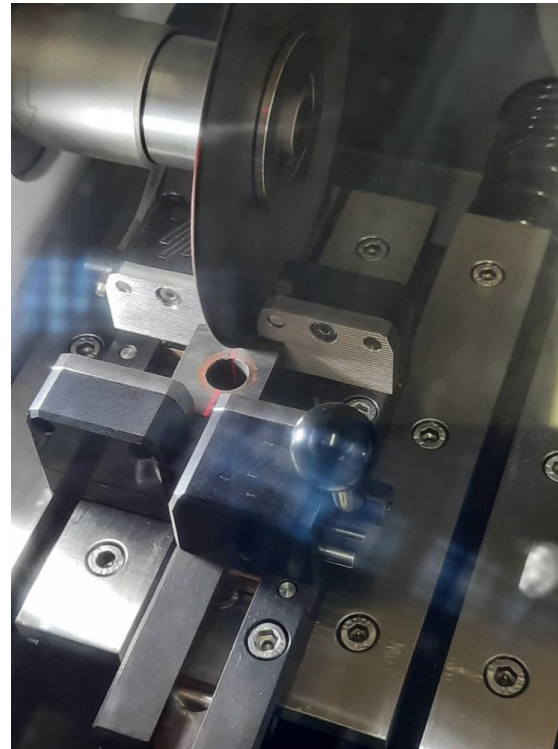
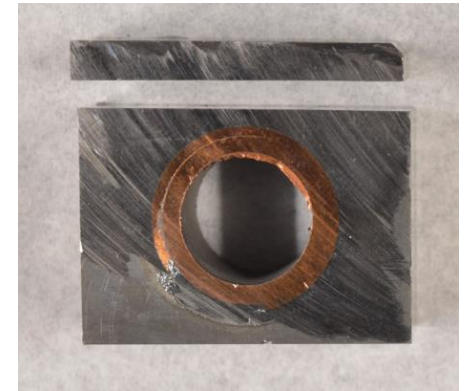
W monoblock samples cutting is now starting !

- ▶ precision cutting
- ▶ diamond saw (able to cut hard materials such as W)
- ▶ water free (no surface contamination)
