# **WPJET2: Material erosion, migration and dust**

**Marek Rubel , Per Petersson and JET2 Team**

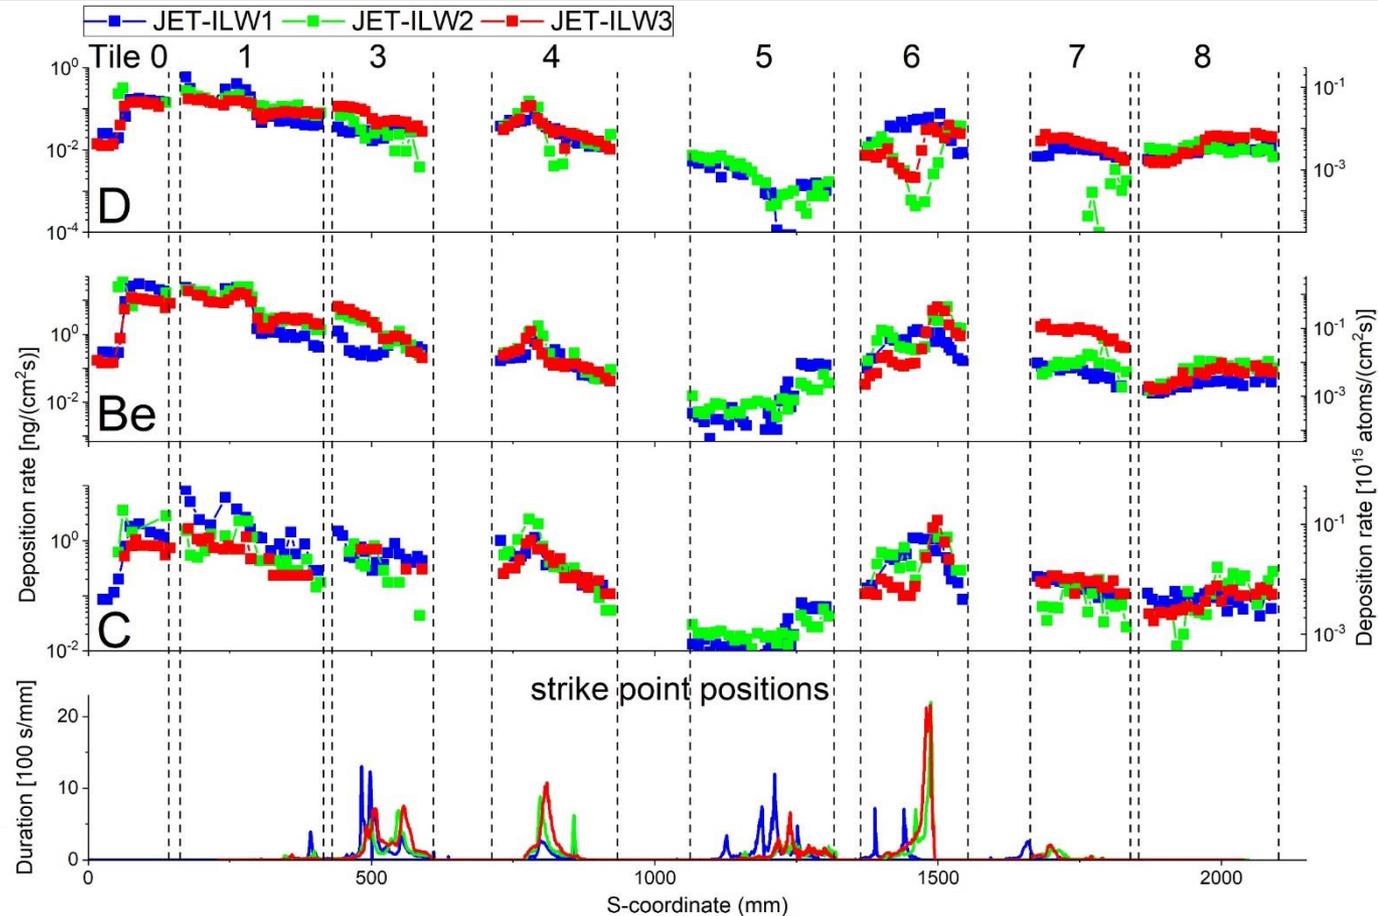
# Divertor: deposition from ILW-1 to ILW-3

- Qualitatively similar distributions in all campaigns.
- Maximum deposition on Tiles 0, 1
- Higher deposition on Tiles 4, 6 in ILW-2 and ILW-3

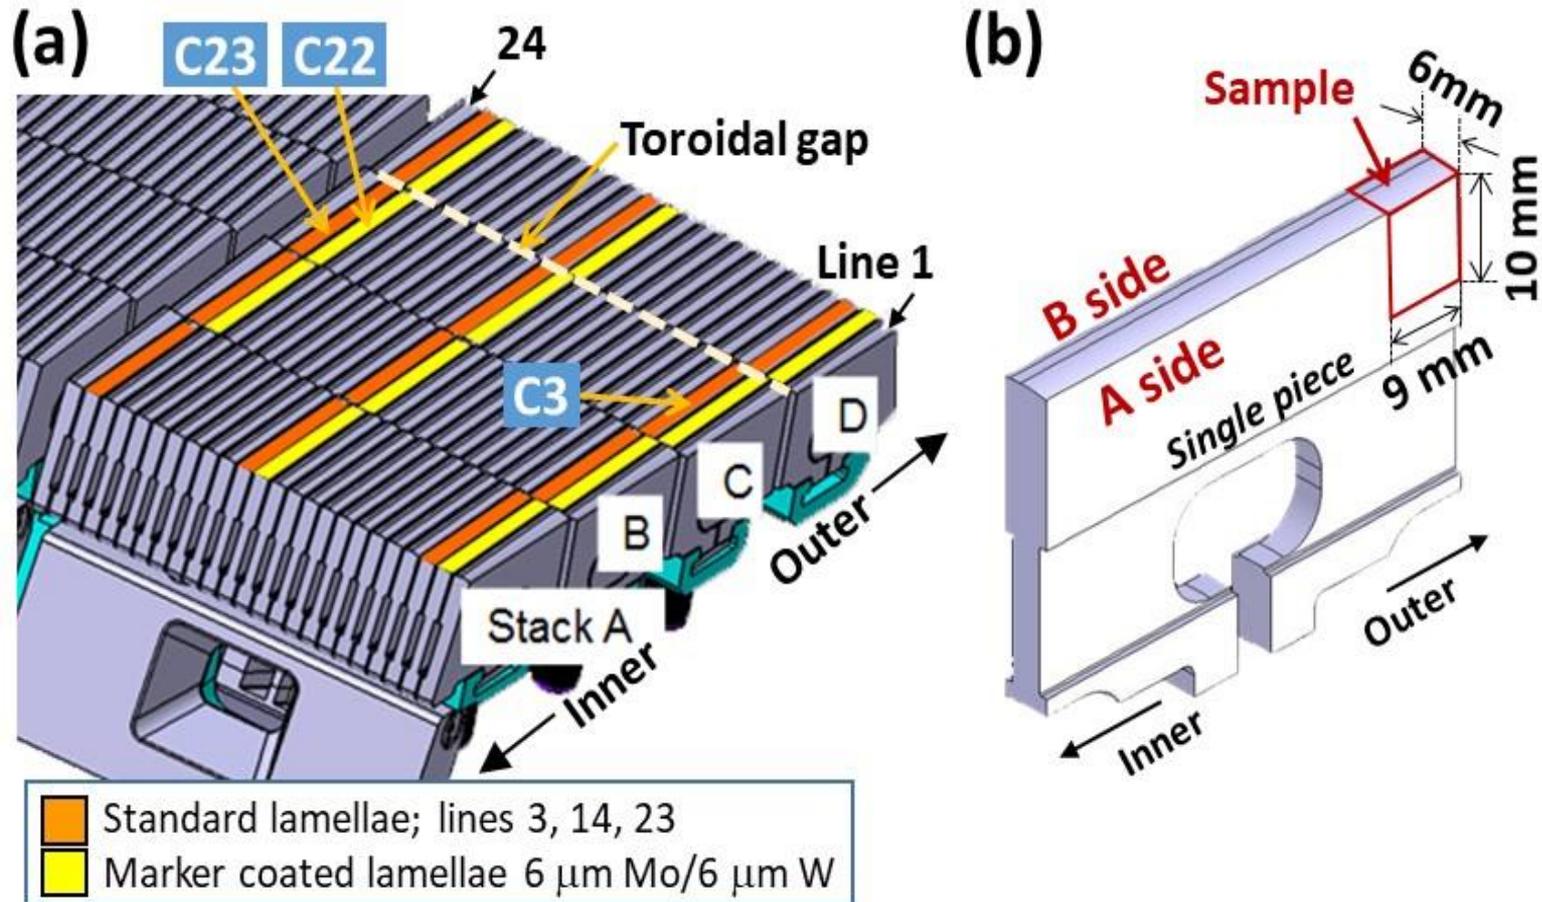
# Divertor: Tile 5, Bulk W lamellae

*Plasma operation mainly on Stack C and D.*

*Lamellae 1-3: in the shadow of the adjacent tile*

*Lamellae 12-14: central part of the assembly*

*Lamellae 20-24: most exposed*

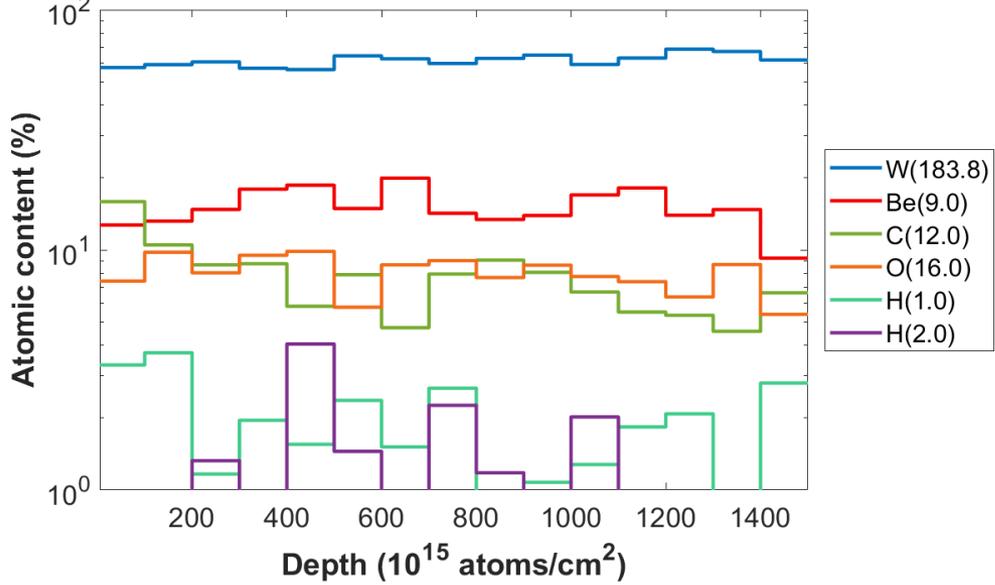
## ILW-2, lamella C3 (sample 55)

Deuterium content:  $1.7 \times 10^{16} \frac{\text{at.}}{\text{cm}^2}$   
 Hydrogen content:  $3.2 \times 10^{16} \frac{\text{at.}}{\text{cm}^2}$

**More Hydrogen than Deuterium**  
*(End of ILW-2 campaign in hydrogen.)*

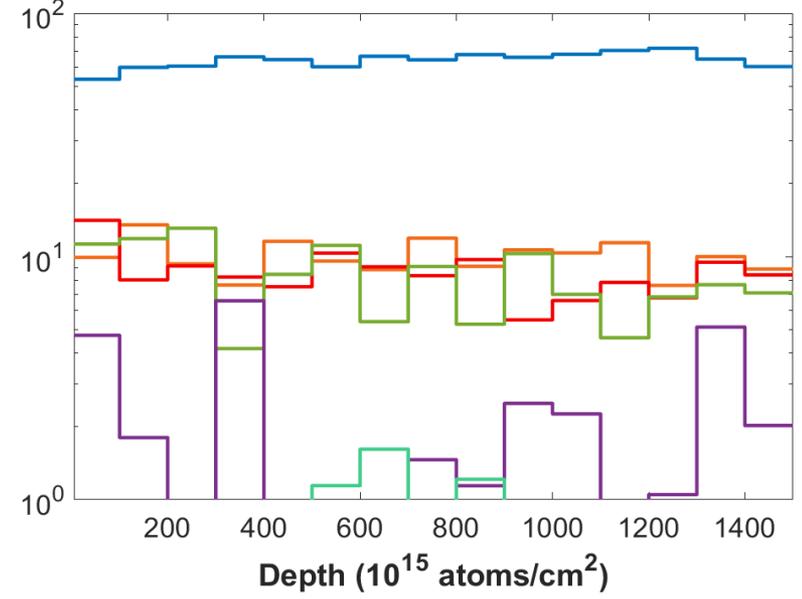
## ILW 1+3, Lamella C2 (sample 104)

Deuterium:  $3.1 \times 10^{16} \frac{\text{at.}}{\text{cm}^2}$   
 Hydrogen:  $1.1 \times 10^{16} \frac{\text{at.}}{\text{cm}^2}$

**More Deuterium than Hydrogen**

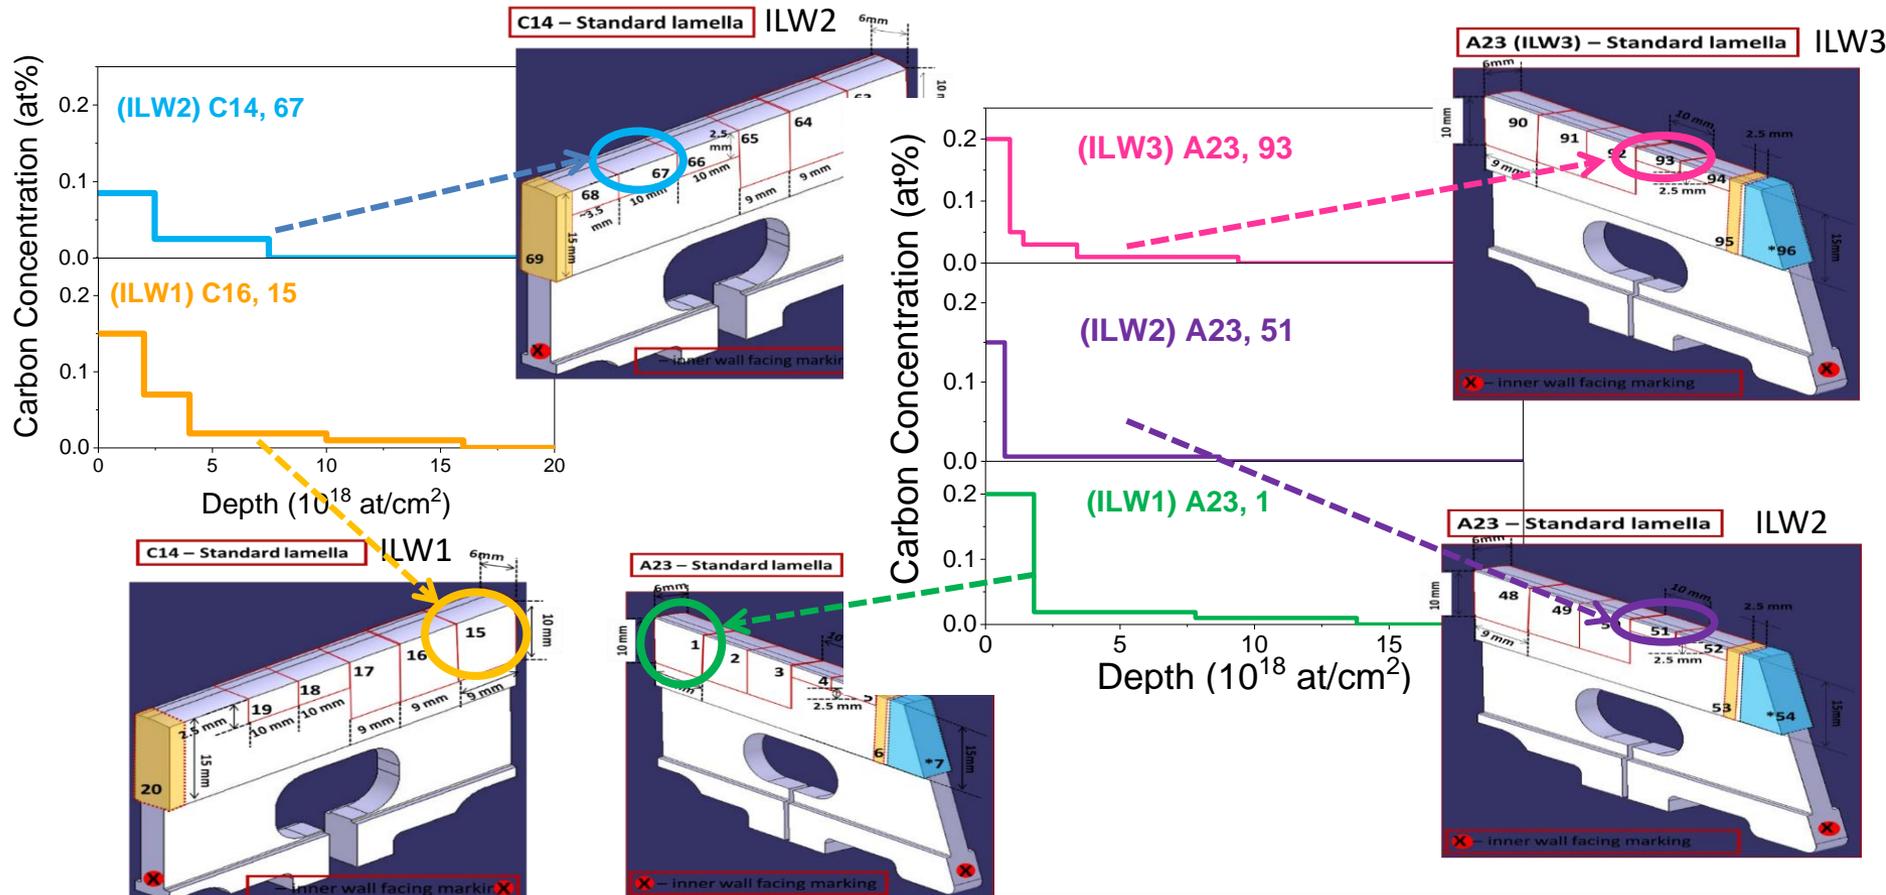
# Carbon on W lamellae: Deuterium NRA on top surfaces

Lamella	Experiment Period	Sample No	Carbon ( $10^{17}$ at/cm <sup>2</sup> )	Deposition thickness ( $10^{18}$ at/cm <sup>2</sup> )
A23	ILW 3	93	3.25	9.4
A23	ILW 2	51	1.53	8.7
A23	ILW 1	1	5.34	13.8
C14	ILW 2	67	3.38	7.5
C14	ILW1	15	6.14	16

- The highest **carbon** deposition with the largest thickness is observed in ILW-1 samples.
- Central lamella in ILW1 presents the highest **carbon** amount and larger thickness overall

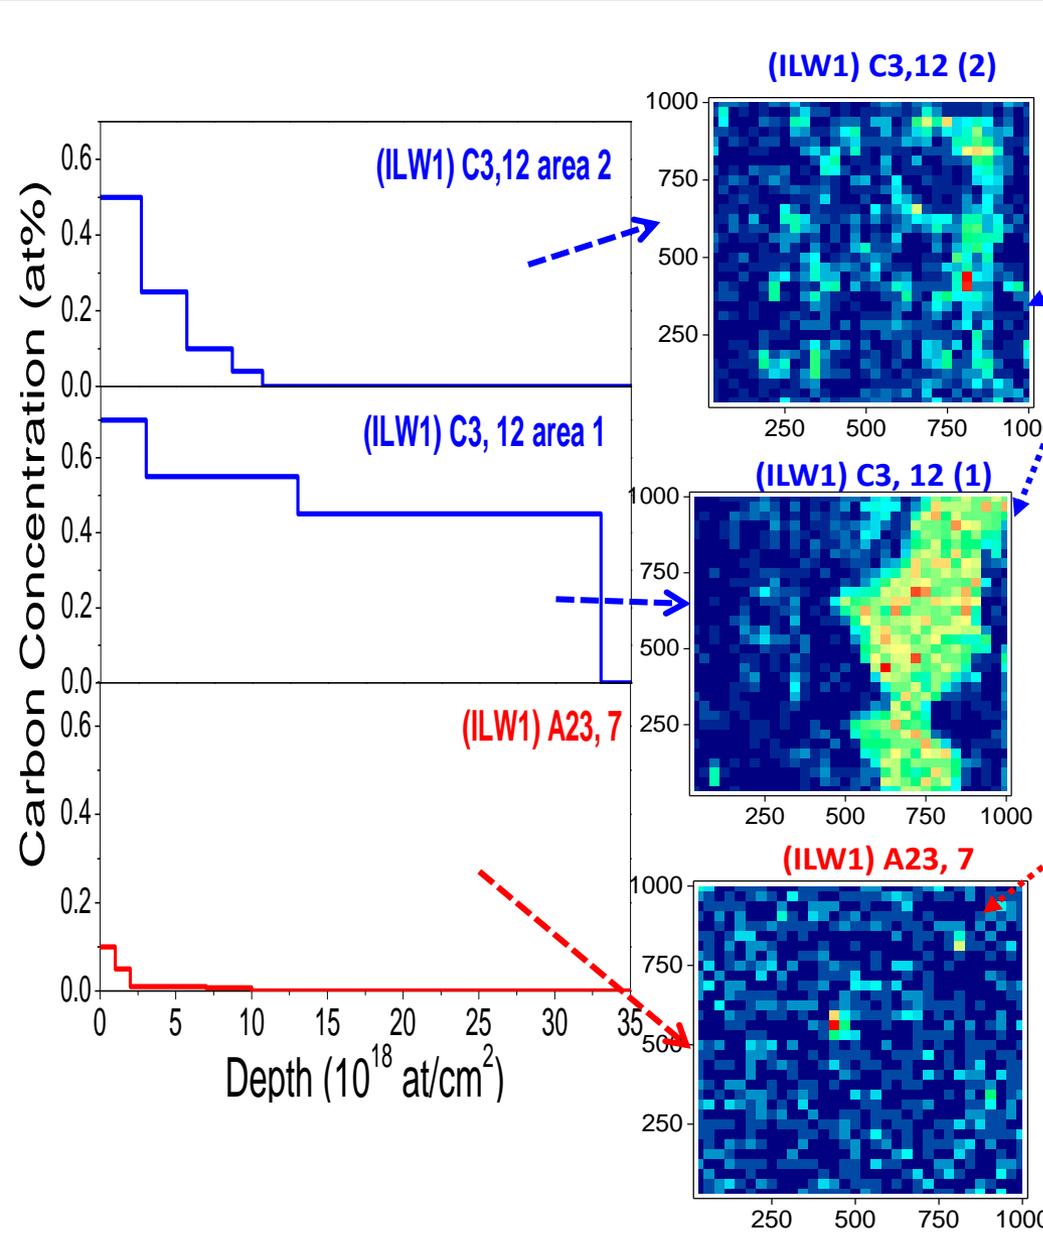
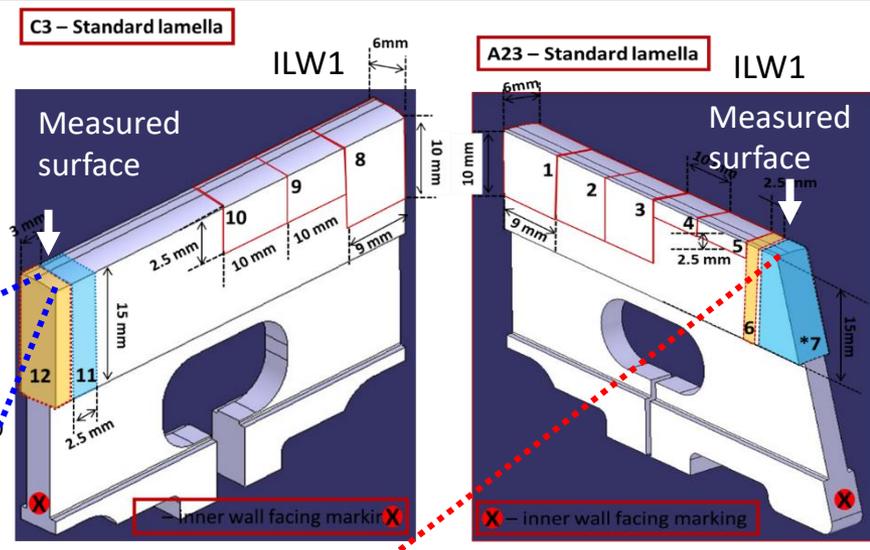
# Carbon on W lamellae: D micro-beam NRA on top surfaces

Lamella	Exp. Period	Sample	C Amount ( $10^{17}$ at/cm <sup>2</sup> )	Deposition Thickness ( $10^{18}$ at/cm <sup>2</sup> )
C3	ILW-1	12 (2)	24.8	10.7
C3	ILW-1	12 (1)	166	33
A23	ILW-1	7	2.21	10

- C3,12 during ILW1 presents stripe-like C deposition having a width varying between  $\sim 100 \mu\text{m}$  (area 2) and  $\sim 250 \mu\text{m}$  (area 1) and 2 to 3 orders higher C amount than other W lamella.
- Carbon agglomerates with diameter of  $\sim 50 \mu\text{m}$  in A23,7

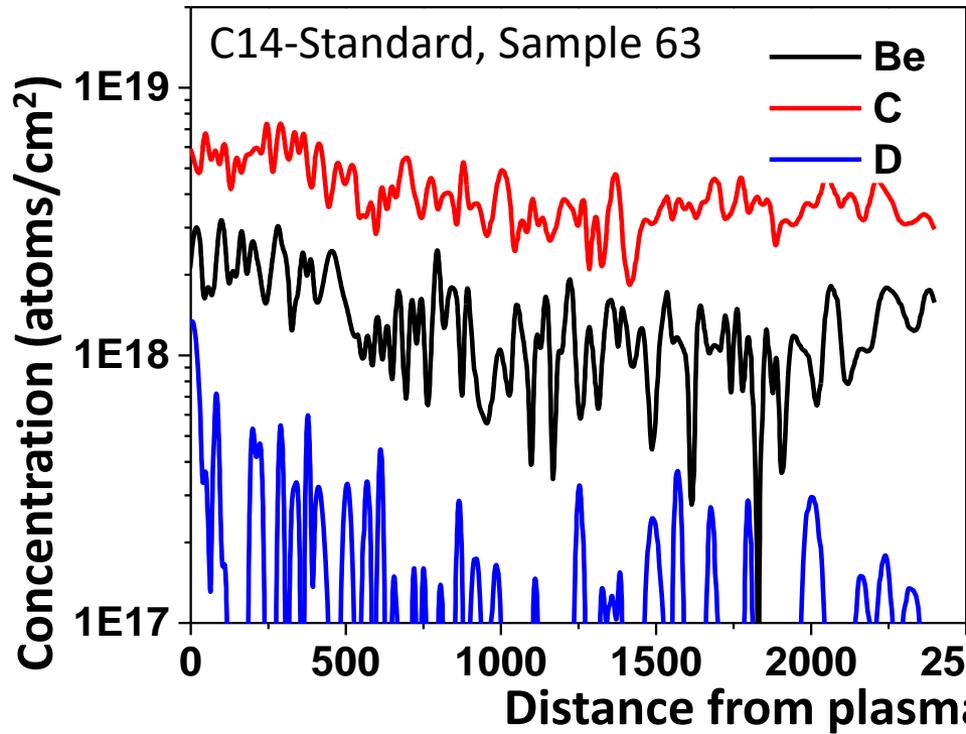
0.4 mm wide gap to another lamella

- Deposition increases with the gap width.
- Relatively high C content,  $C/Be > 1$ .
- Coherence with T deposition pattern in gaps between stacks.

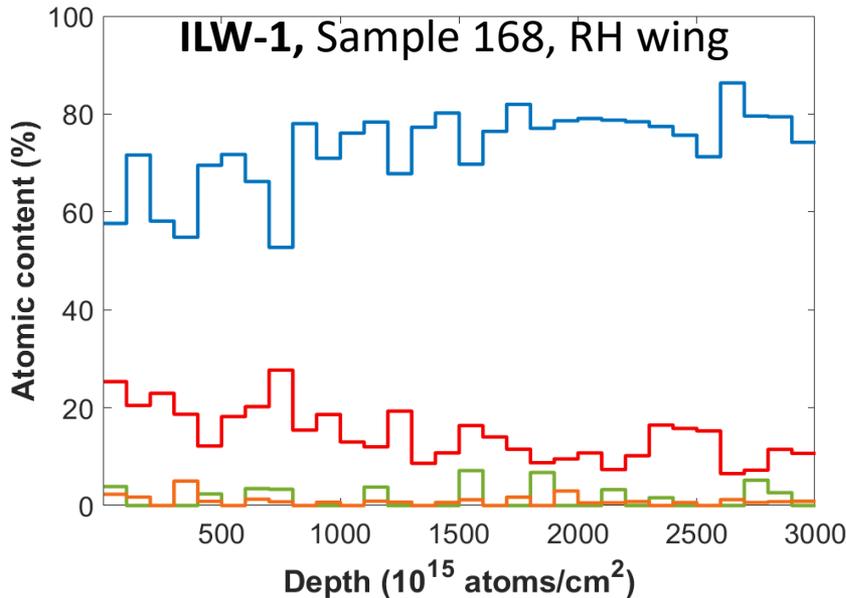
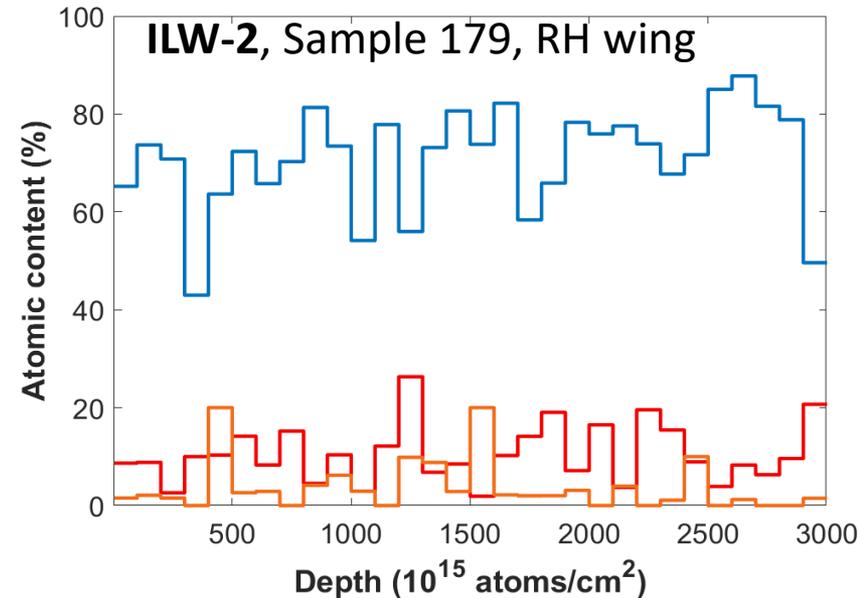
# Beryllium Inner Wall Guard Limiters: ILW-1 and ILW-2

Deuterium content:  $4.8 \times 10^{16} \frac{\text{at.}}{\text{cm}^2}$   
 Hydrogen content:  $2.7 \times 10^{16} \frac{\text{at.}}{\text{cm}^2}$

Hydrogen content:  $1.2 \times 10^{17} \frac{\text{at.}}{\text{cm}^2}$

**No Deuterium on ILW-2**  
*(The result of ILW-2 campaign finish in H)*

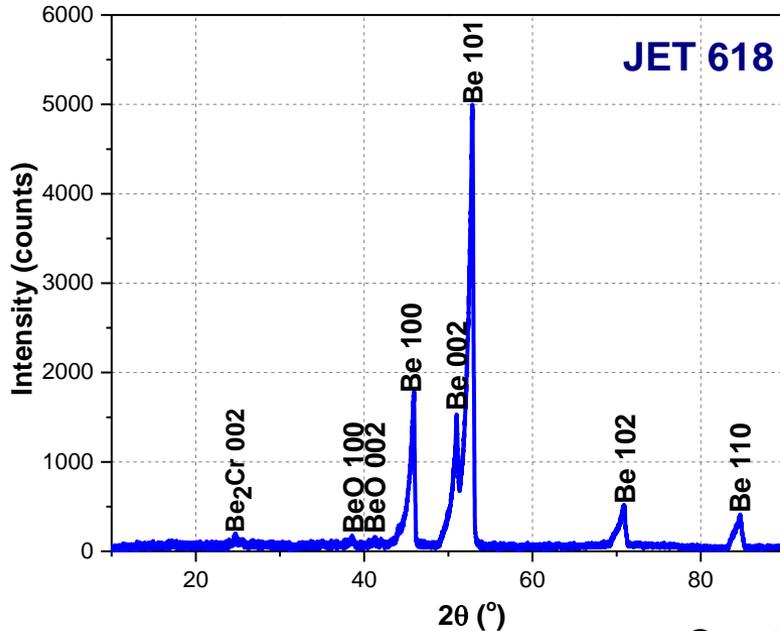
## Inner Wall Guard: 2XR11

➤ Be; BeO (bromellite)

➤ 13.48 nm (618)

- No significant changes in crystalline phases observed on all the samples.
- No other peaks corresponding to other elements (impurities) observed.

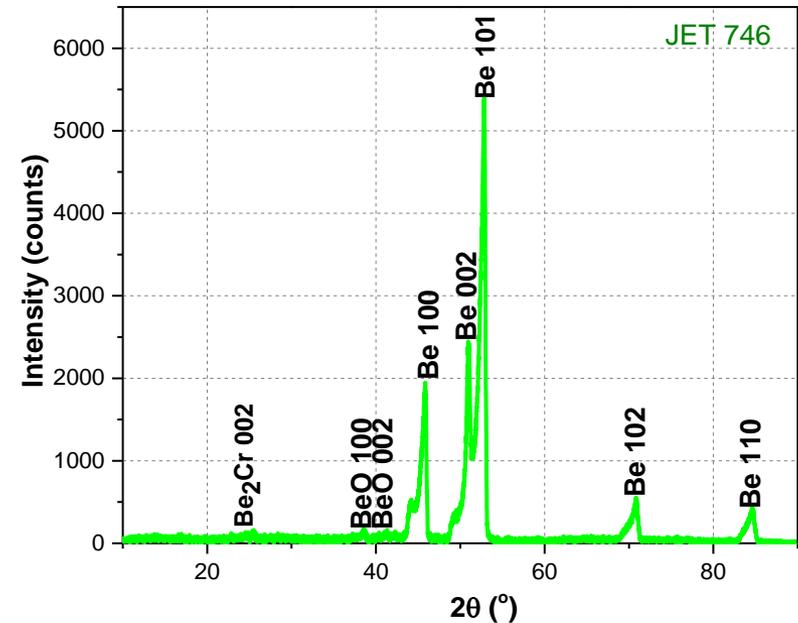
## Outer Poloidal: 4D15

➤ 11,83 nm (746)

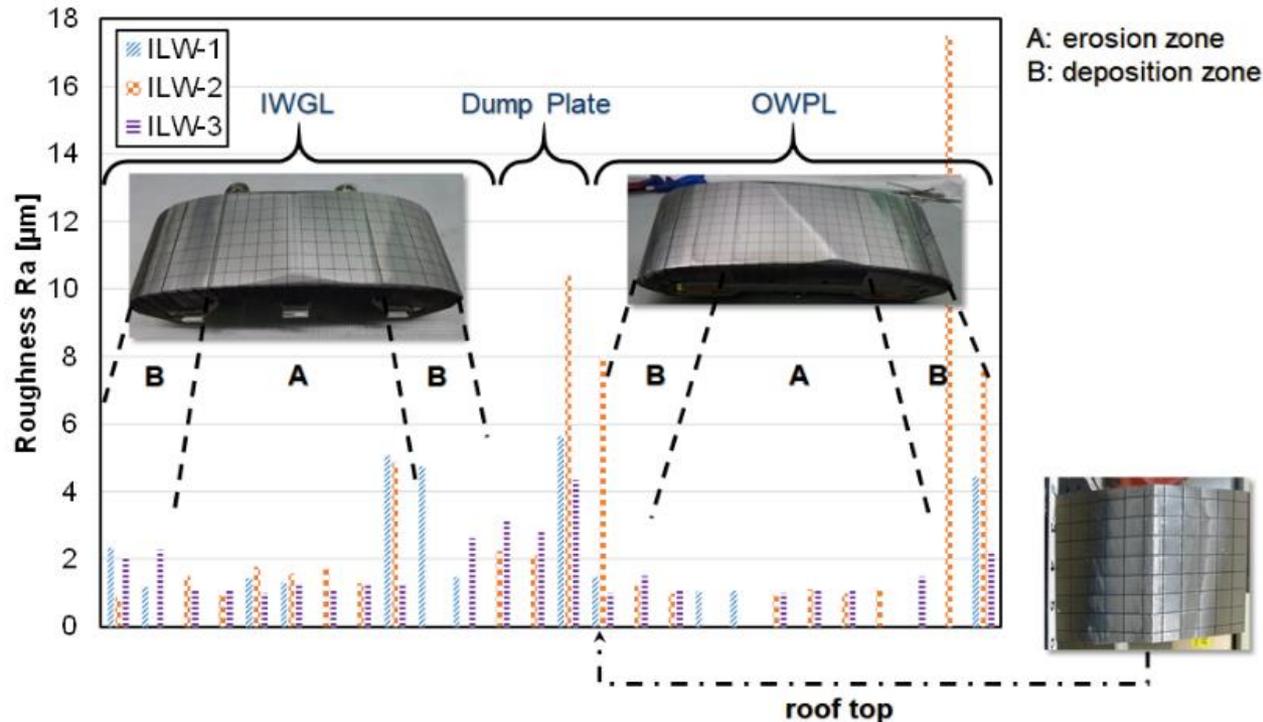
# Be limiters ILW-1 to ILW-3: Surface Roughness

- ❖ Enhanced either by melting (dump plate) or in the deposition zones.
- ❖ Hardly any effect for the erosion zones.
- ❖ For ILW-1 and ILW-3 almost identical results.
- ❖ Significantly increased roughness on OWPL, ILW-2.

- ❖ In ILW-3 areas with full or partial erosion of the Be top layer.
- ❖ ILW-3: In contrast to ILW-1 and ILW-2 no areas with melting.
- ❖ For the dump plate no relevant erosion nor melting of the roof top was found (specimen 462, 2B2C); 2B4C (not part of this investigation) shows heavy melting.
- ❖ Metallographic results showed more or less full erosion of the marker layer in all the locations, at least in the cross sectional micrographs no Ni-remains were found as it was the case for ILW-1 and ILW-2.

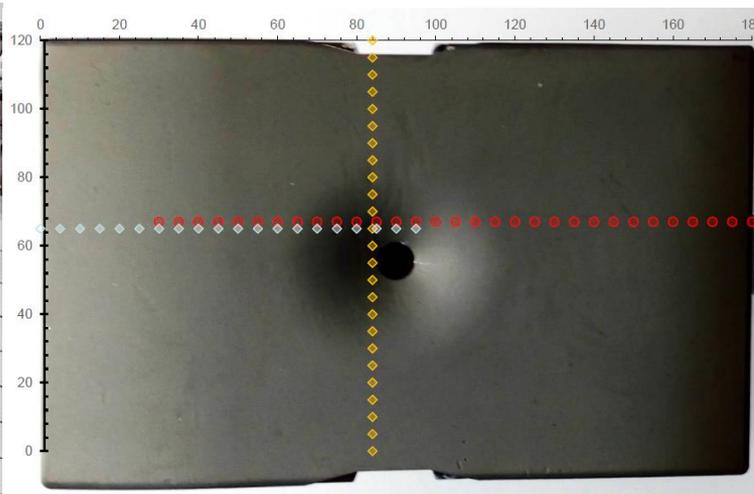
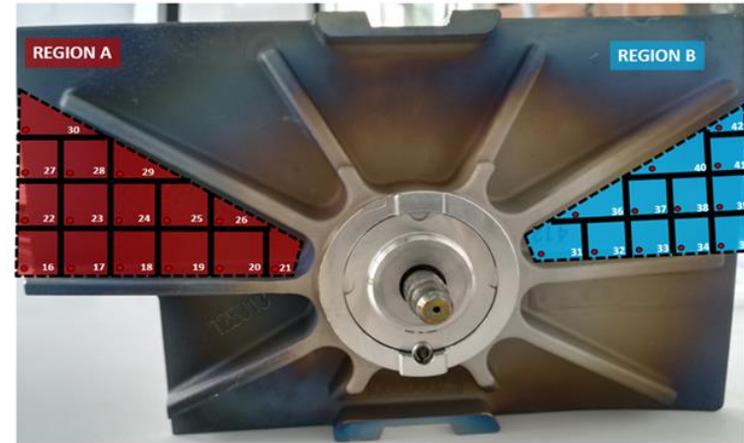
IWC – 412(2011-16) cutting plan

Be  
on  
Inconel

Total IWC surface area:  $\sim 9 \text{ m}^2$

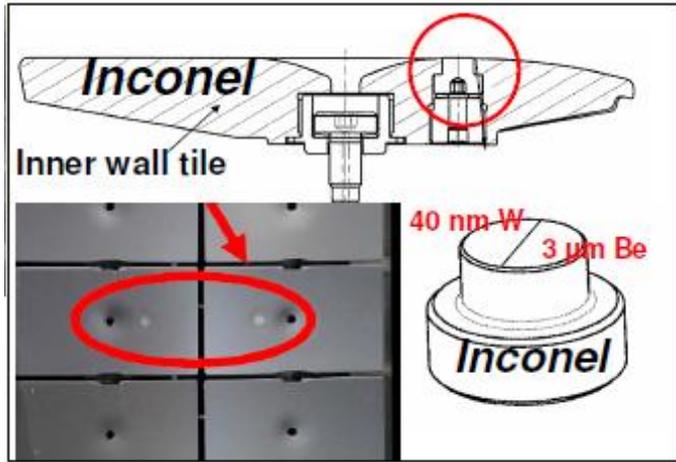
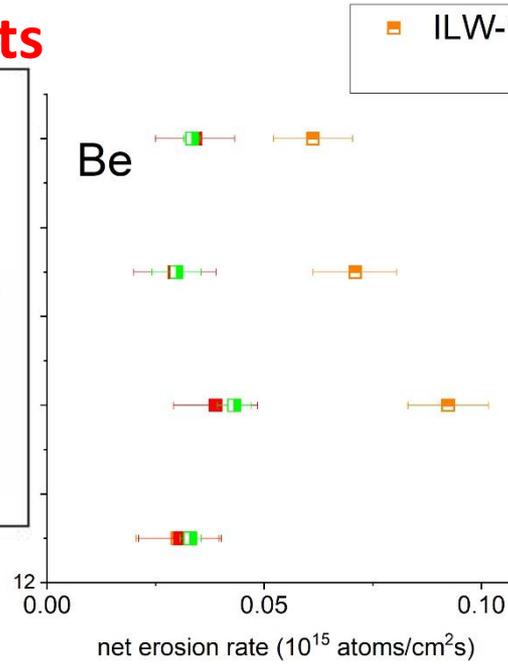
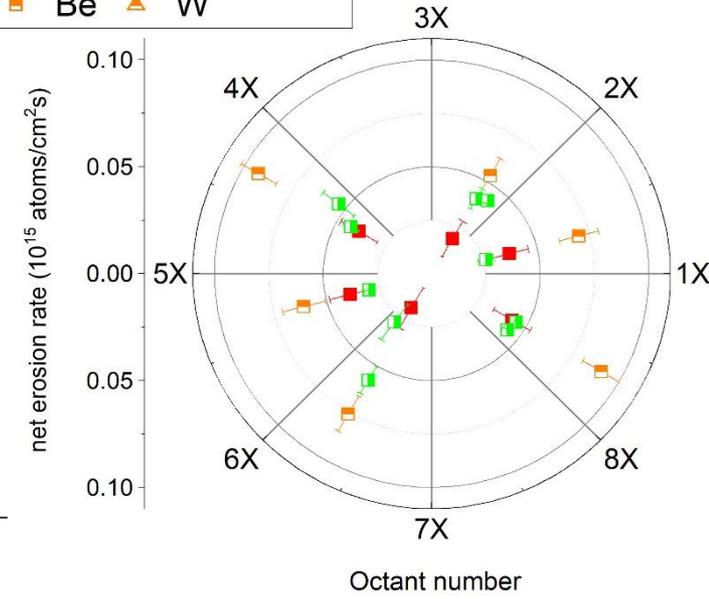
## Data for Be/W Wall Inserts

- Fairly homogeneous erosion rate in toroidal and poloidal directions, both for Be & W.
- Variation of erosion rate within factor 2 for all 3 ILW campaigns
- Very small erosion rate for W < 0.3 pm/s

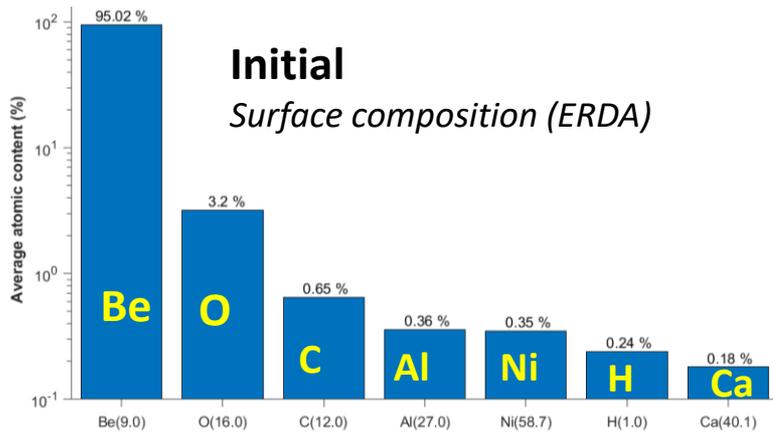
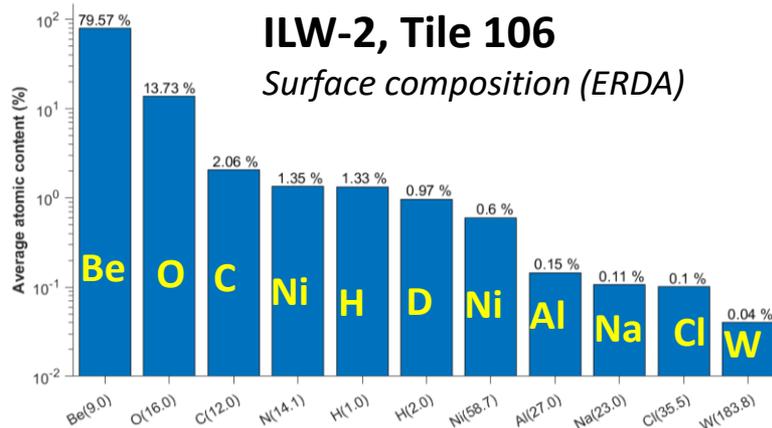
# Inner Wall Cladding: ERDA and <sup>3</sup>He-NRA

The average composition of the sample to a depth of  $6000 \times 10^{15}$  atoms/cm<sup>2</sup>

- *Low or no layer erosion.*
- *Probably Be deposition from eroded limiters*
- *Low fuel retention, both at the surface and in the bulk.*
- **Total D inventory: 0.8 - 5.4 x10<sup>21</sup> (3 – 21 mg)**
- *Microscopy is needed to check topography.*

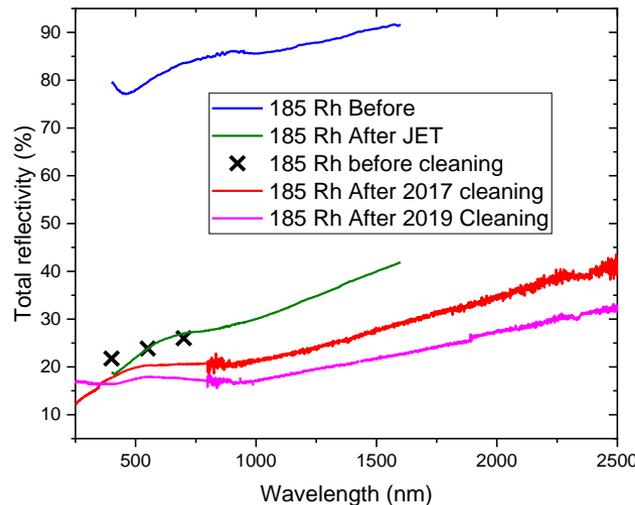
Height Sensor 200.0 nm

220 eV He ions are reducing the amount of Be (393 nm to 37 nm) but not removing the final layer.

XPS shows an enrichment of W oxide that stopped the cleaning.

Adding 3 h in 2019 (in comparison to 23 h for 2017) is not reducing the Be amount as measured by HIERDA.

Reflectivity not recovered for these steps, Ar gas is required.

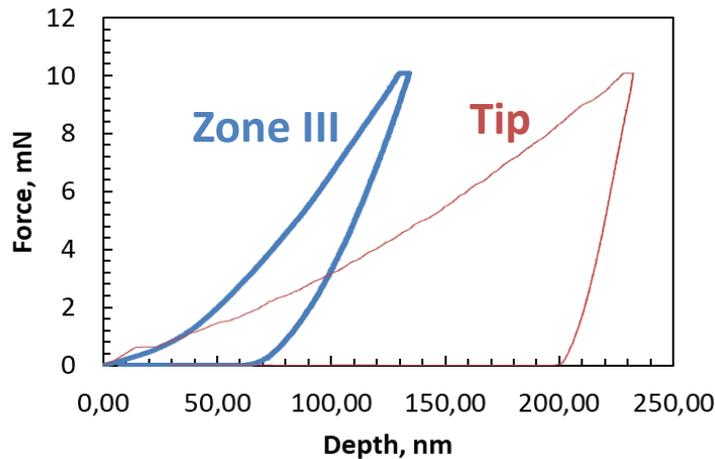
## Comparison of force-depth curves for both areas.

- *Hysitron Ti-800 triboindenter.*
- *Force 10 mN.*
- *15 measurements in each area.*

- *Due to the large development of the surface, the surface was imaged in the SPM (scanning probe microscope) mode before each measurement.*
- *Large differences in the hardness between the tip and Zone III.*

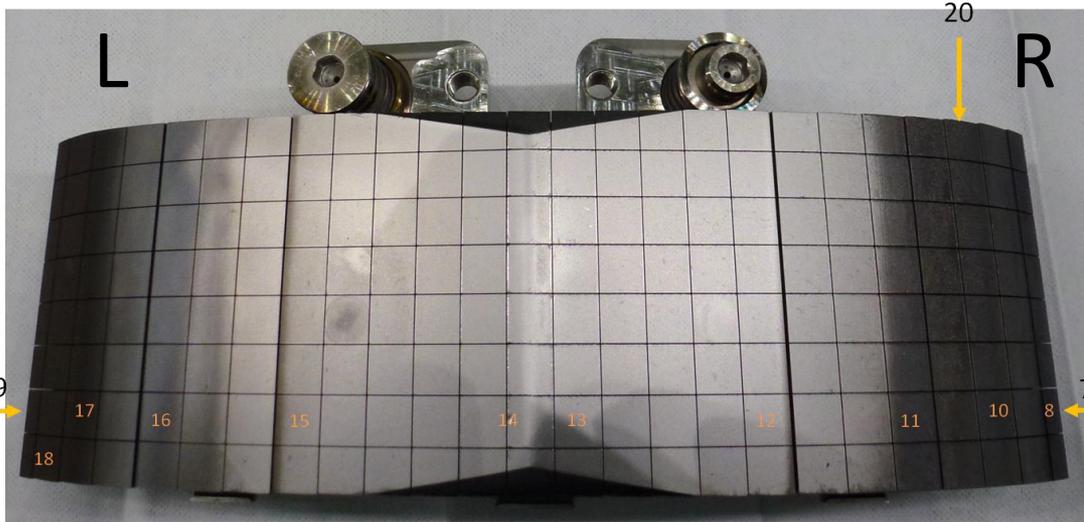
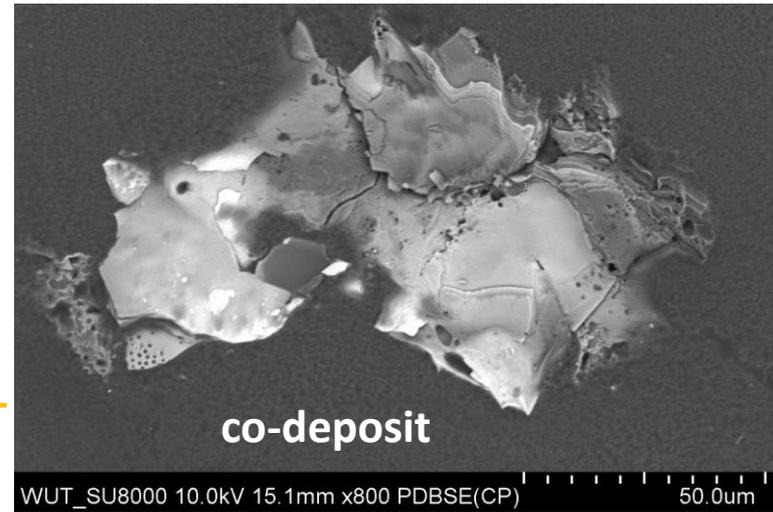
# Dust: Inner Wall Guard Limiter 2XR11 ILW1-3

- Numerous splashes, co-deposits and irregular objects with empty interior.
- Strong adherence of particles to the substrate.

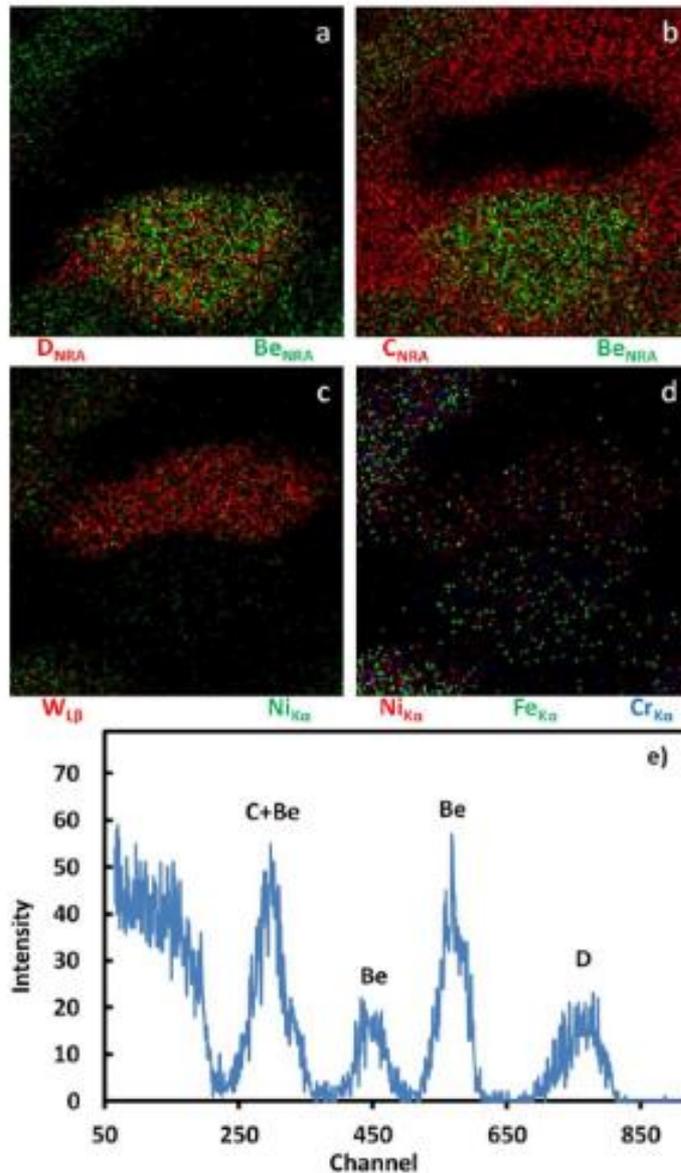
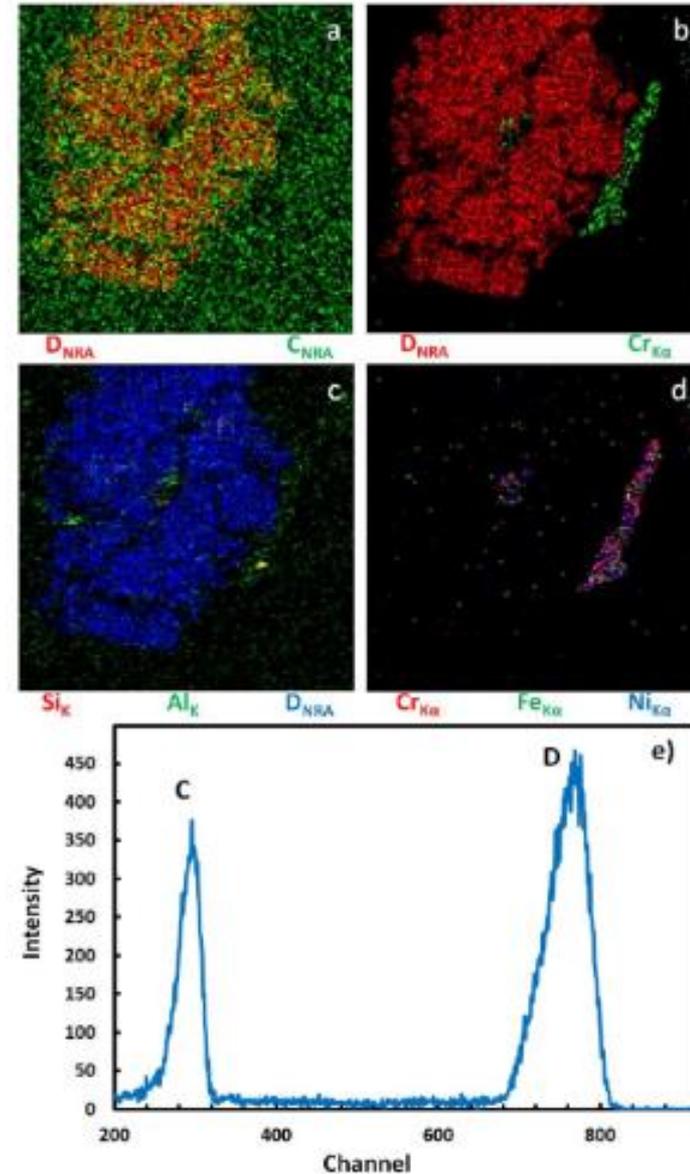
# Dust collected by vacuum cleaning after ILW-3: Ion Micro-beam Analysis

**D retention is associated mainly with C:**

***~ 10–20 times greater than in metal-based particles.***

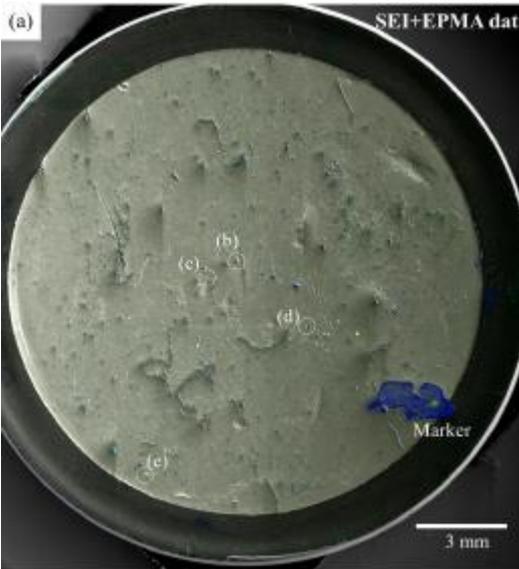
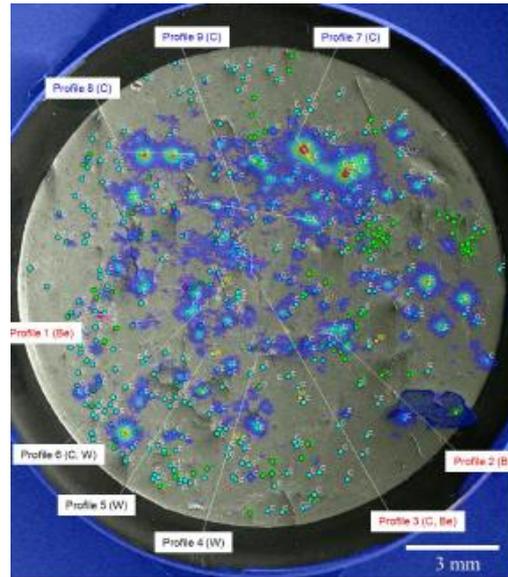
## Radiography of T in different particles (ILW-1)

- *Dust particles are placed on In disk.*
- *Composition of individual particles is identified with EPMA (WDS).*
- *$\beta^-$  (T) recorded by radiography.*
- *Superposition of profiles.*

**Tritium presence associated with C.**

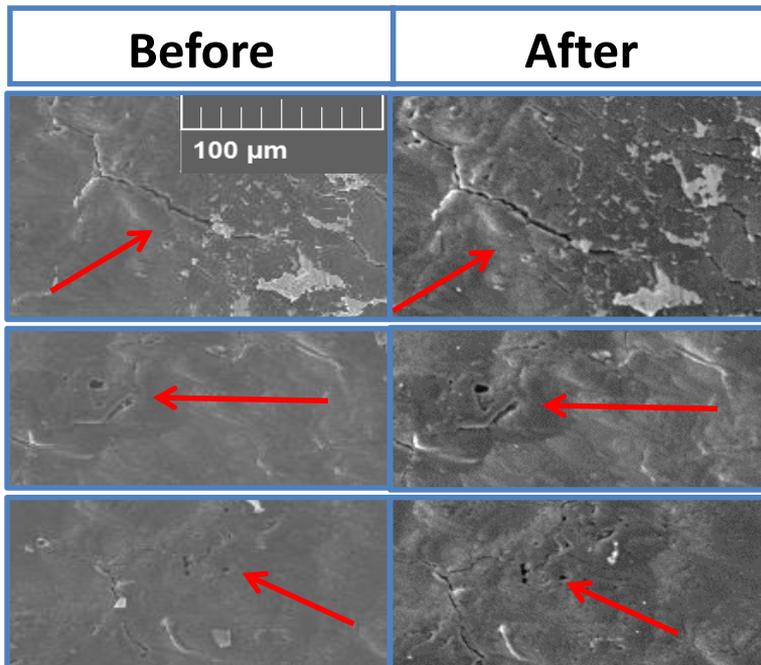
Current status: One sample with deposit (cut from 2XR10 tile IWGL) “cooked” for ~4 h.

- Exposure of Be with deposit doesn't lead to “mechanical” damage to the layer: no cracking or large-scale flaking.*
- No flakes/dust found in the flask → mechanical stability of the deposit exposed to boiling water.*
- Agreement (a & b) with data obtained in earlier experiments. (P. Petersson, E. Fortuna, 2019)*
- Tritium detected in water:  $\sim 6 \times 10^{11}$  atoms ( $\sim 10$  % of total T inventory within the sample)*

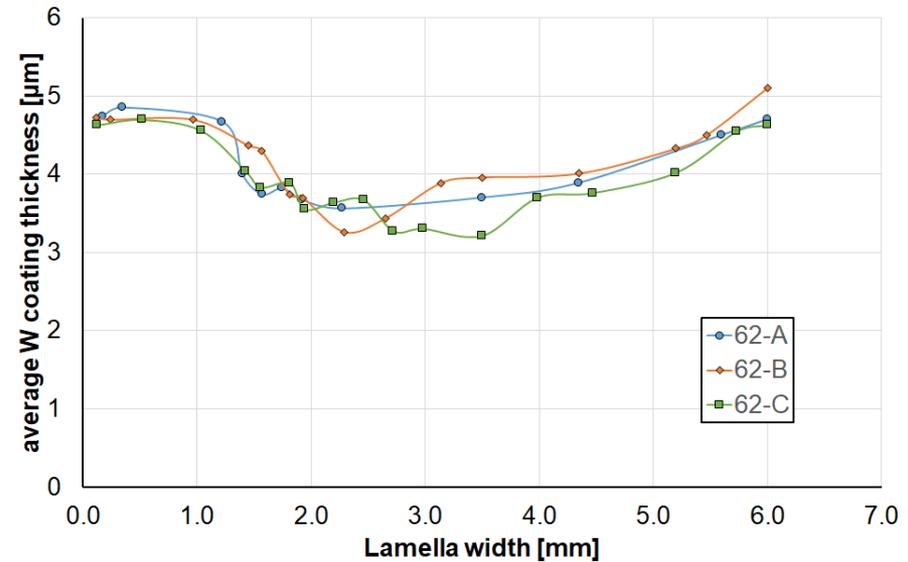
measurement @  $\geq 5$  positions

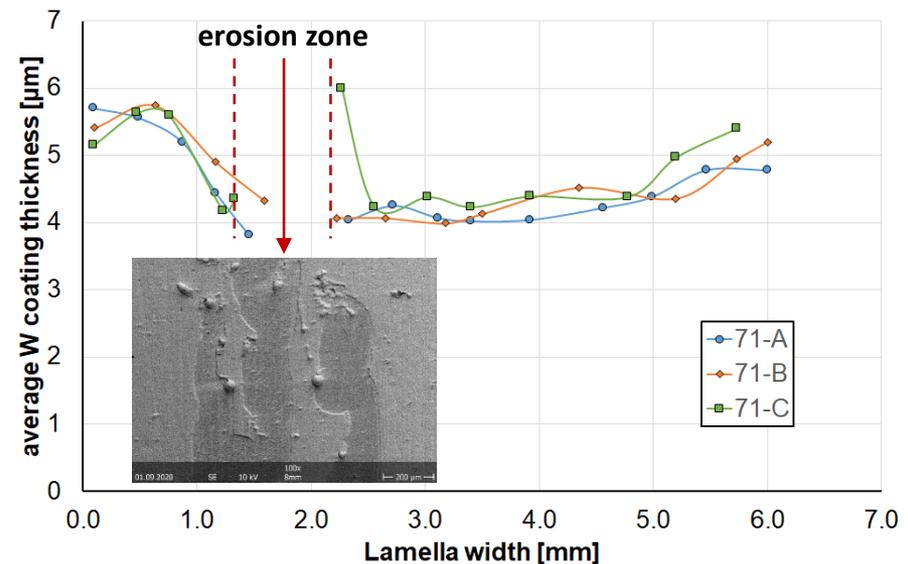
Measurement not always possible due to ablation/melting
