**JT-60SA**

Status Update  
06 September 2022

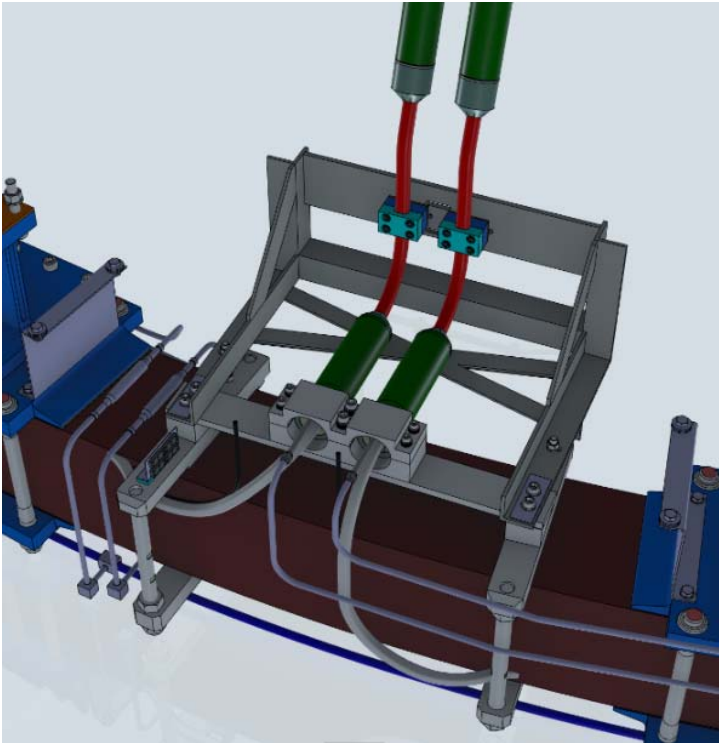
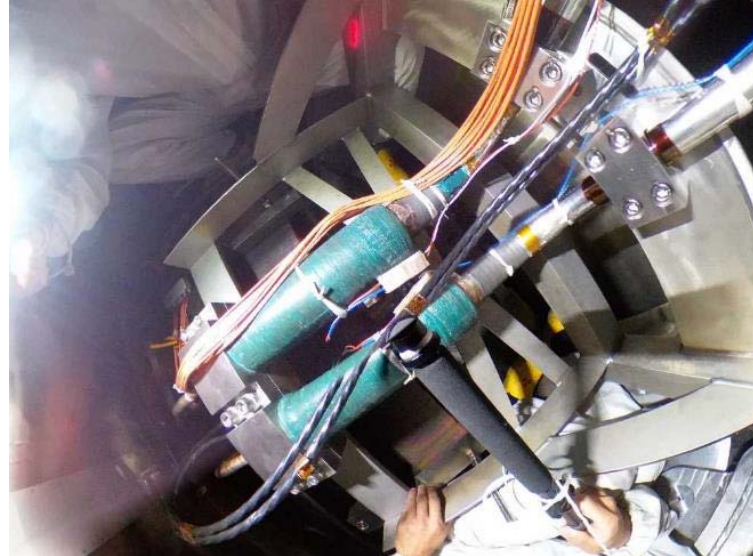
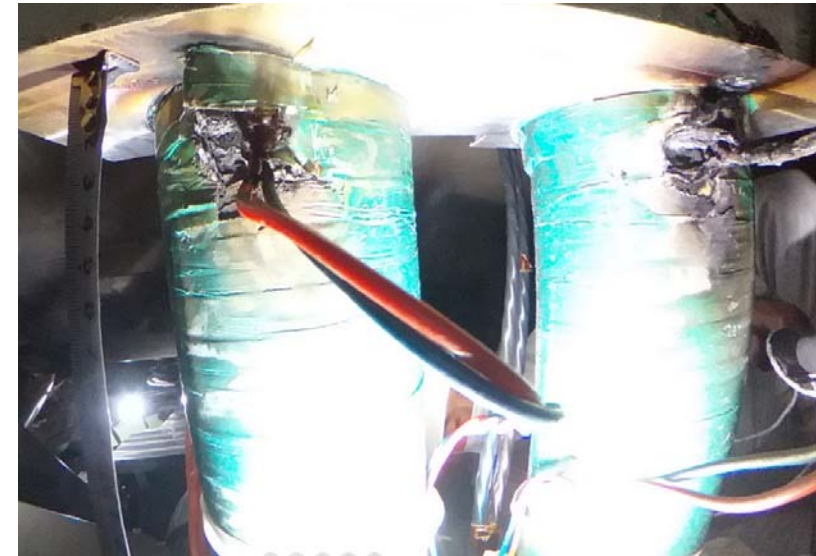
- Arc occurred between the EF 1 terminals on 09 March 2021 with 350 A in the coil
- Exact failure mechanism is still unknown since no degradation of cryostat vacuum was detected before the arc
- Target: Paschen-proof tokamak

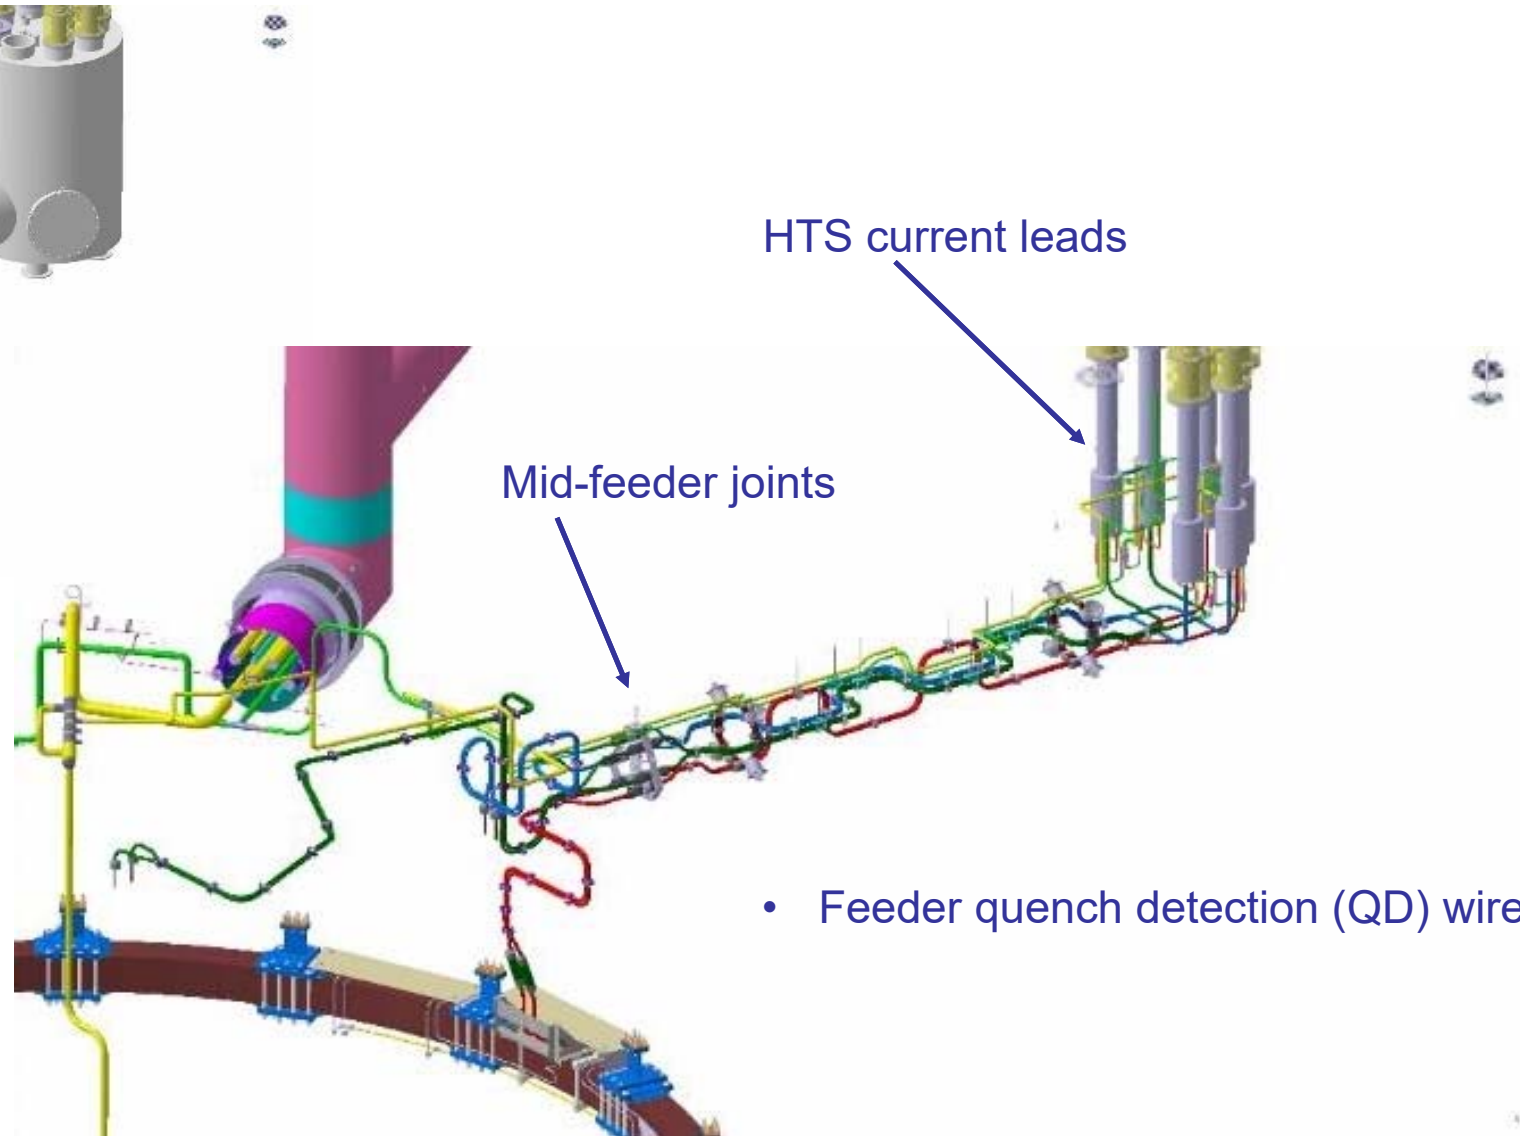
Coil terminal joints

HTS current leads

Mid-feeder joints

- Feeder quench detection (QD) wires

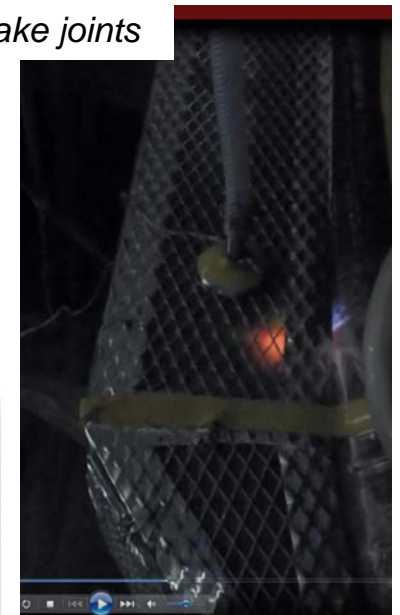
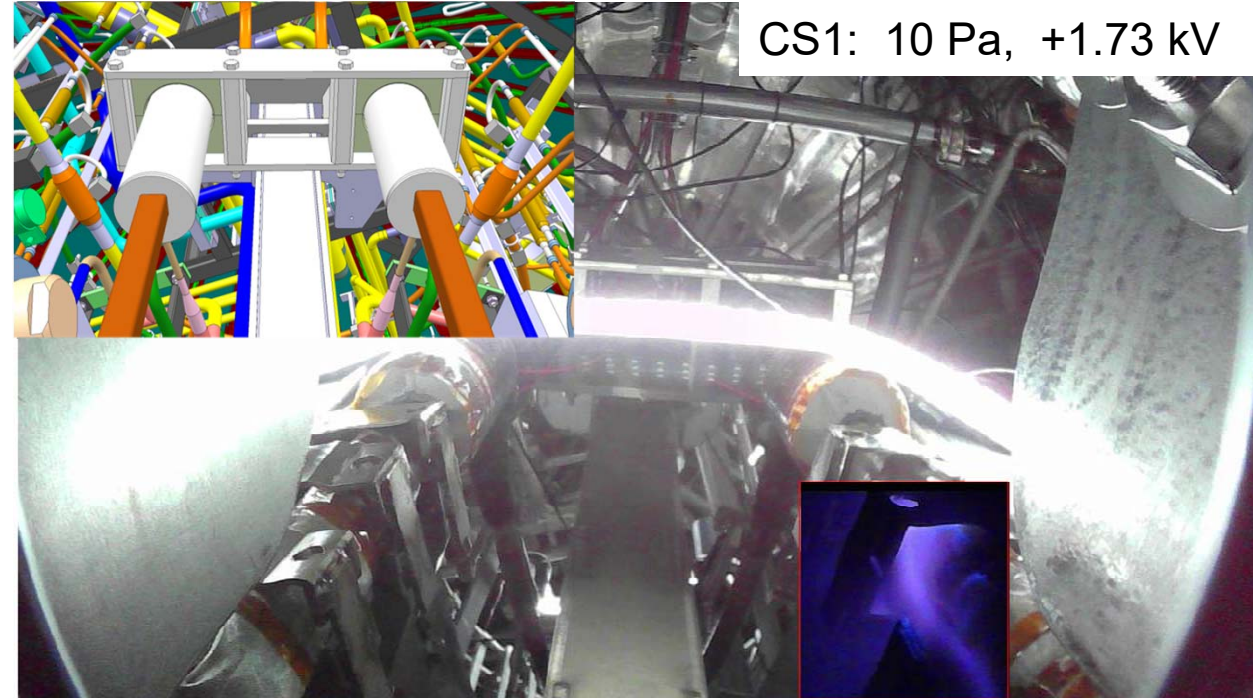
- In many cases, webcams (135) were able to detect visible breakdowns
  - Live observation / software post processing
  - Superposition of breakdowns on illuminated photos
- Some breakdown locations also indicated by
  - spark detectors
  - $\Delta V$  measurement using voltage taps of quench detection system
- Nevertheless, testing under Paschen conditions only reveals the weakest point in each circuit
- F4E / QST no longer consider it realistic to achieve a Paschen-proof tokamak
